## Massachusetts Inland Resource Area Delineation Report

**Report Date:** October 6, 2022

**Project number:** 20150214.B40

**Site Address/Location:** Elmer Brook, at Pearl Street  
42.282717° N, 72.587053° W

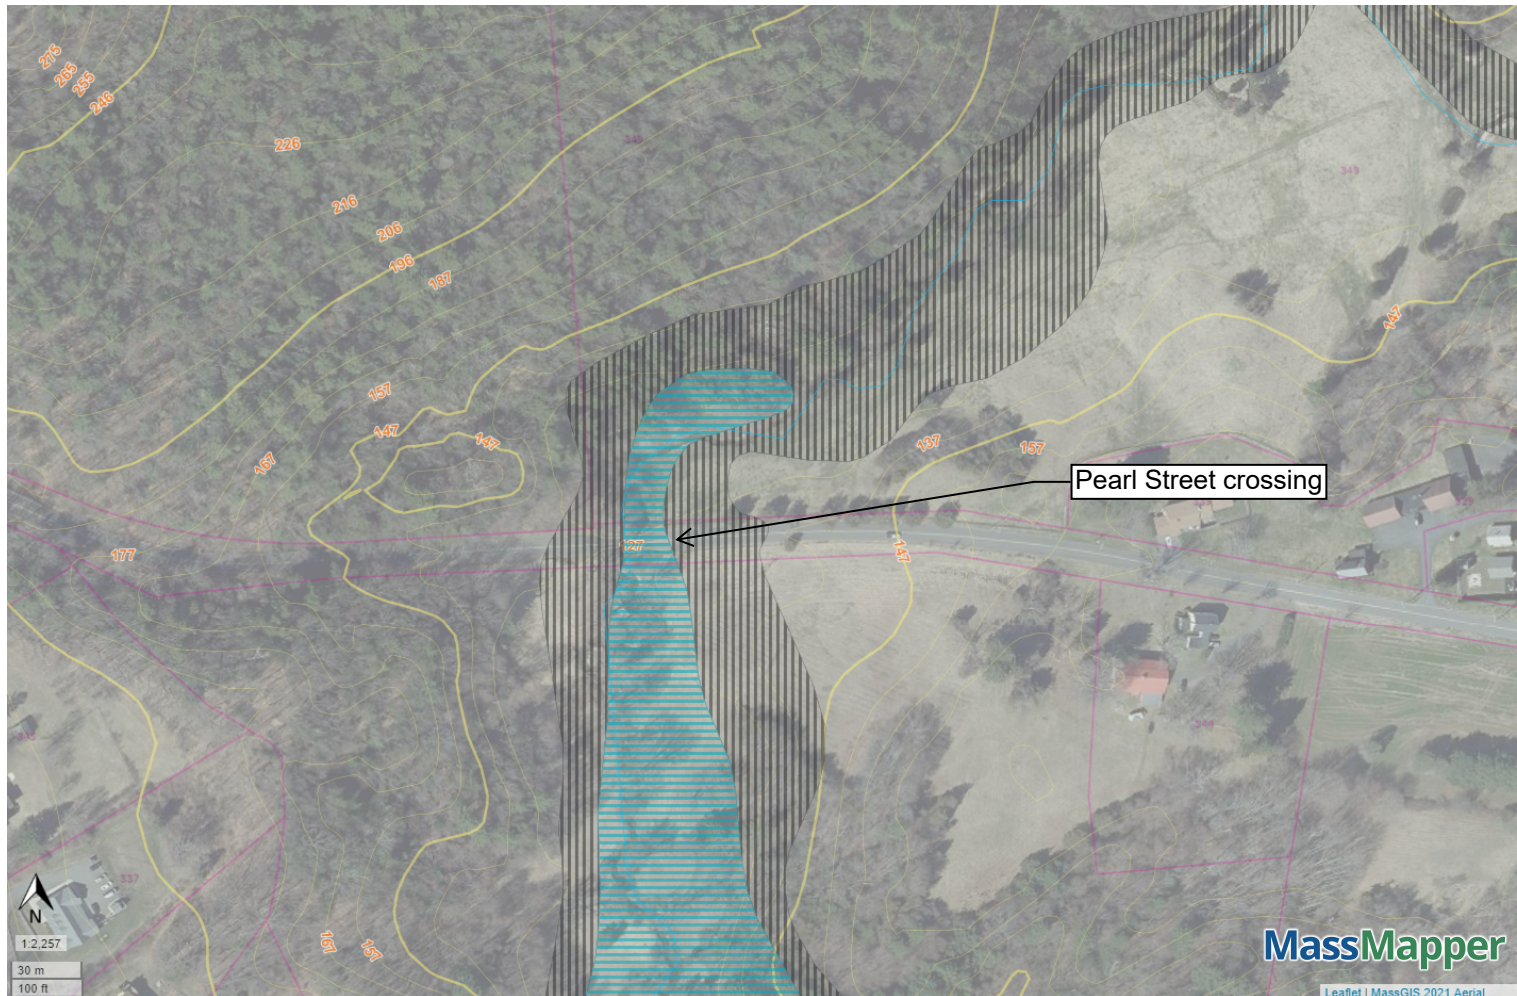
# Pearl Street (S. Hadley MA)

USGS Rivers and Streams 25k

Q3 Flood Zones (from Paper FIRMs, All Available Areas)

(see attached *Flood Insurance Rate Map for the Town of South Hadley, Massachusetts, Hampshire County; Panel 5 of 10*). A more accurate depiction of the 100-year flood zone is based on Fuss & O'Neill's recent modelling of site hydrology under existing conditions. It is my professional opinion that the 100-year flood zone determined in the model accurately represents the lateral extent of BLSF at the Site.

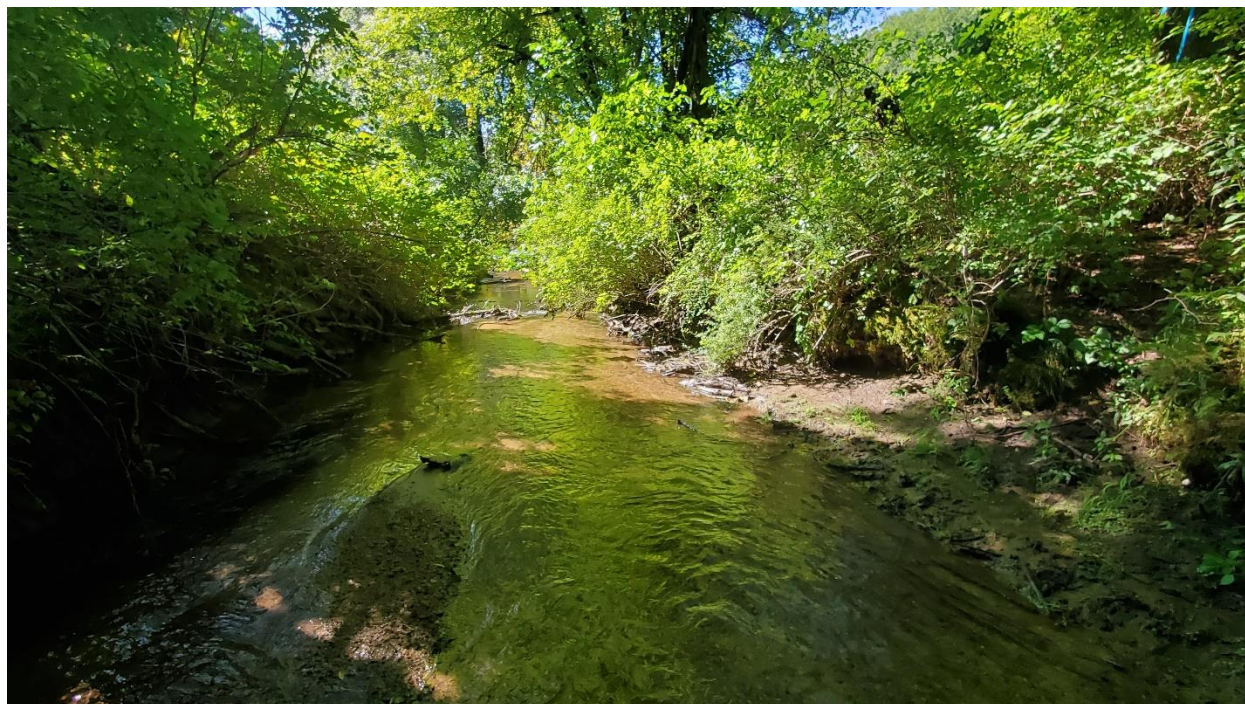
**Photo 1.** A reach of Elmer Brook, located approximately 400 feet downstream of the crossing at Pearl Street. Looking south (downstream) near flag A100.

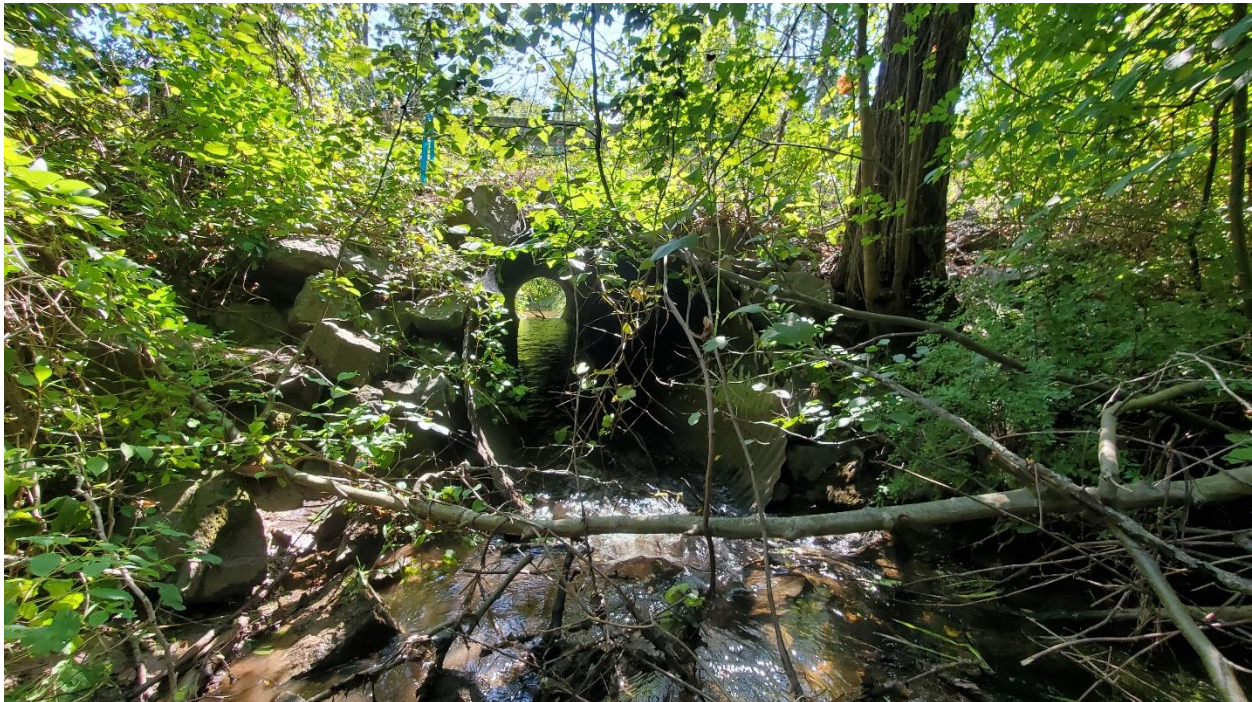
**Photo 5.** A reach of Elmer Brook, located approximately 10 feet upstream of the crossing at Pearl Street; the culvert inlet is at center. Looking south (downstream) near flag C314.

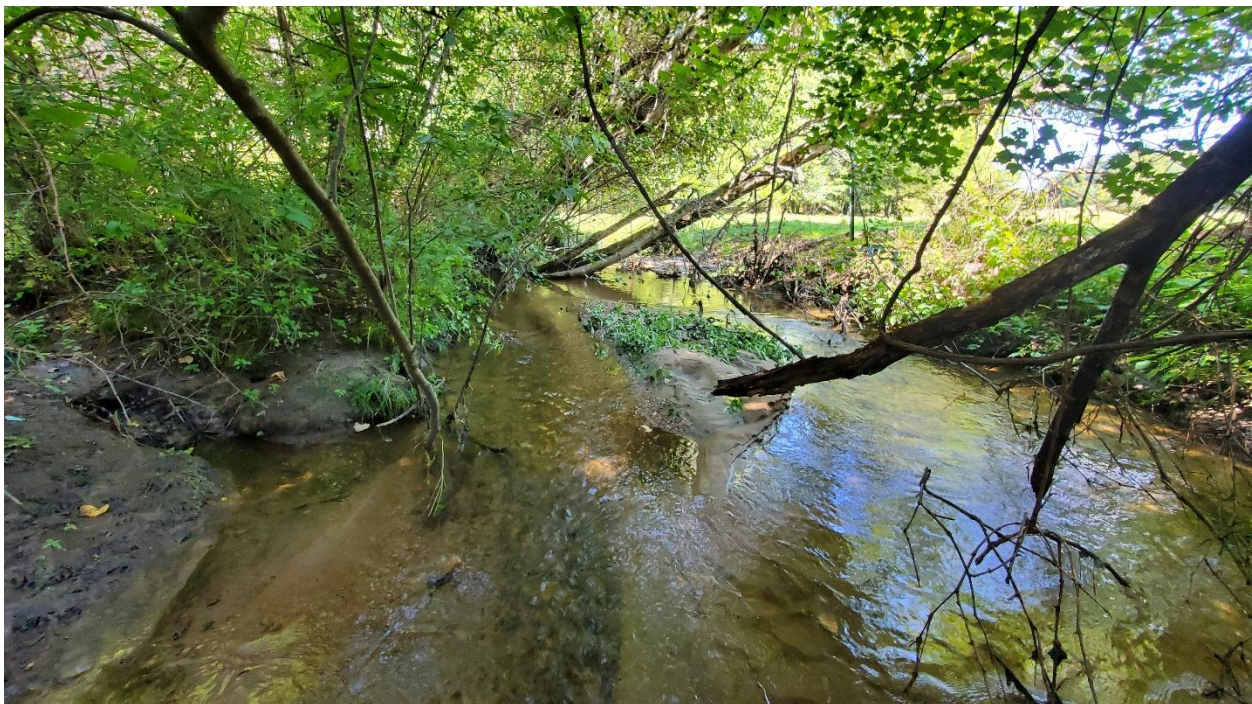
**Photo 6.** A reach of Elmer Brook, located approximately 60 feet upstream of the crossing at Pearl Street. Looking northeast (upstream) near flag A123.

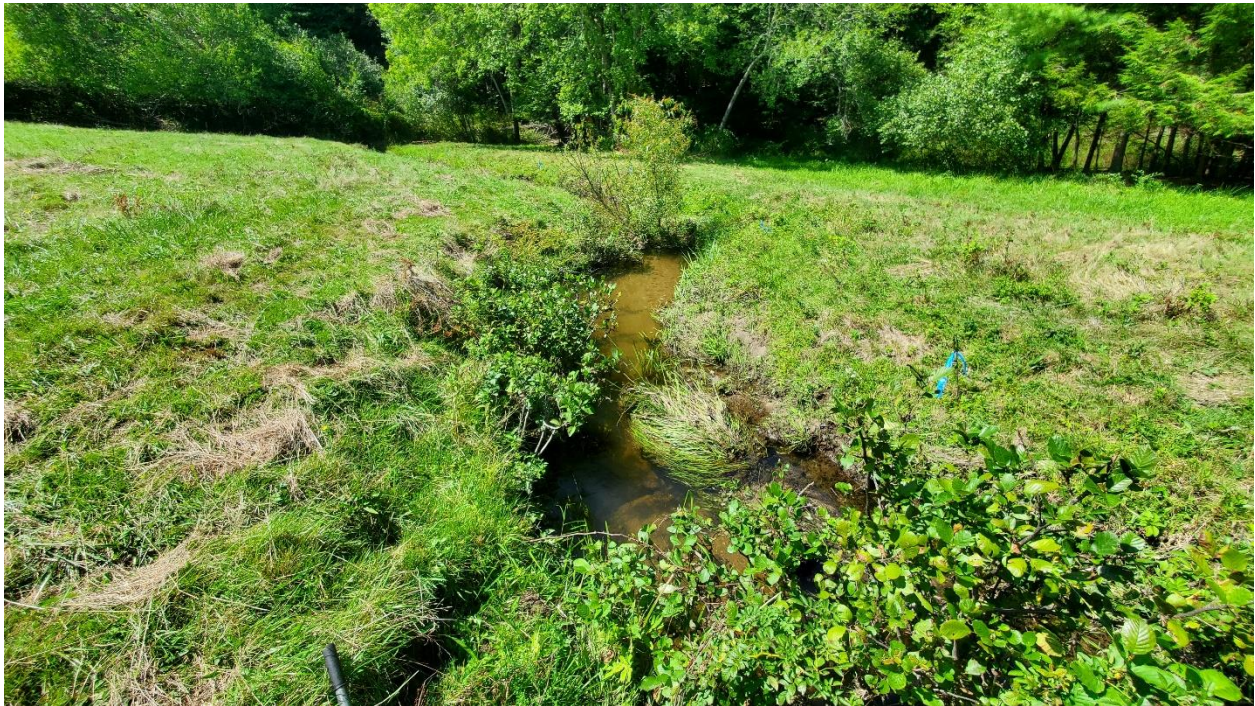
**Photo 7.** A reach of Elmer Brook, located approximately 230 feet upstream of the crossing at Pearl Street. Looking west (downstream) near flag C304.

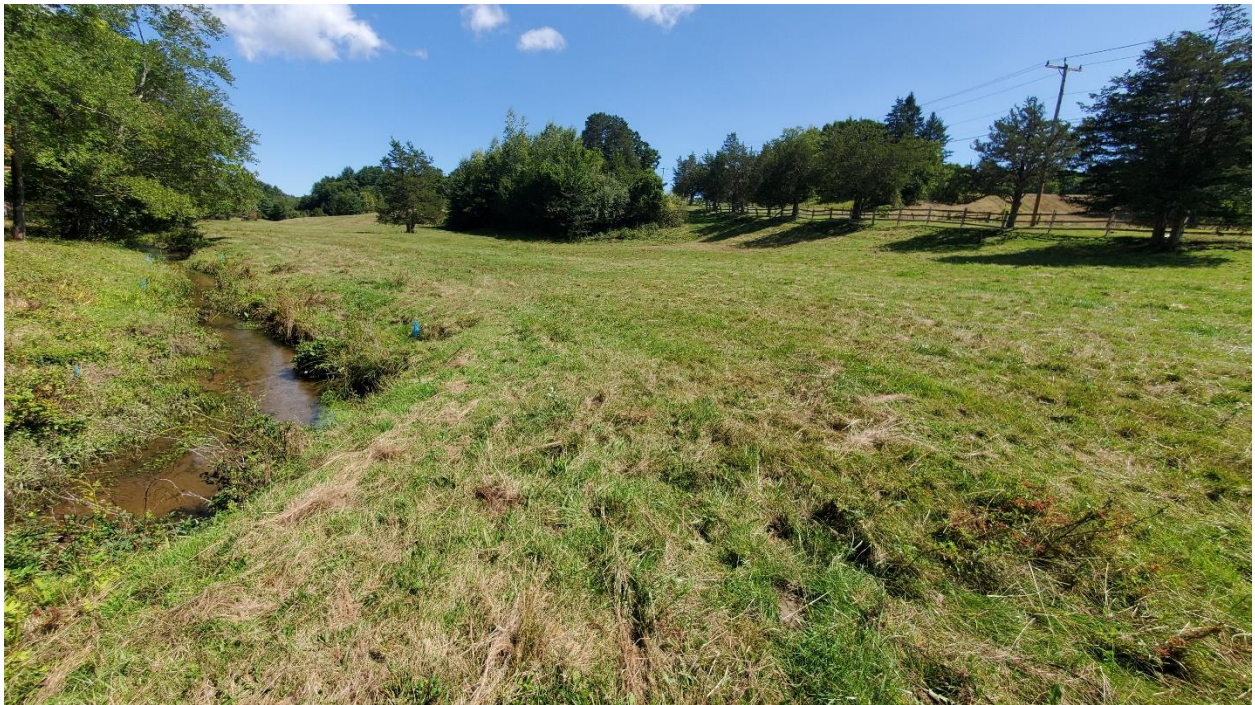
**Photo 8.** A reach of Elmer Brook, located approximately 230 feet upstream of the crossing at Pearl Street. Looking east (upstream) near flag C304.

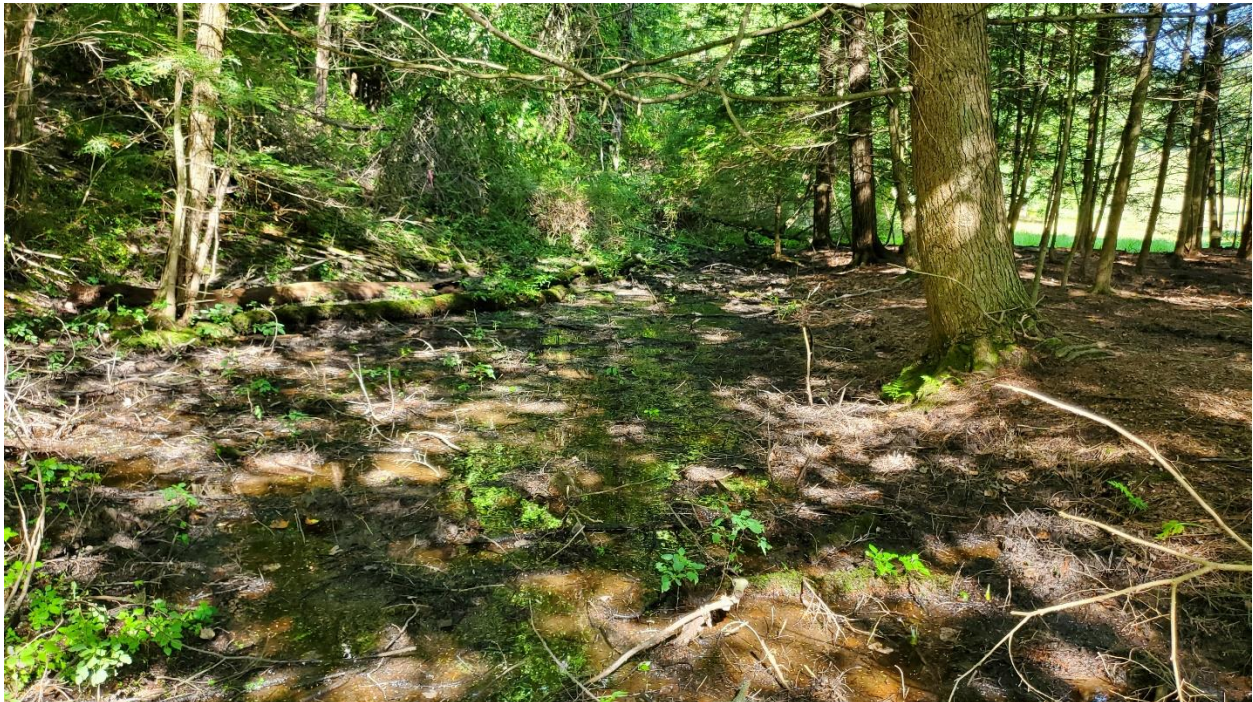
**Photo 9.** Forested portion of BVW located north of Elmer Brook (flag series D400-D414 and E500-E505). Looking northeast near flag D404.

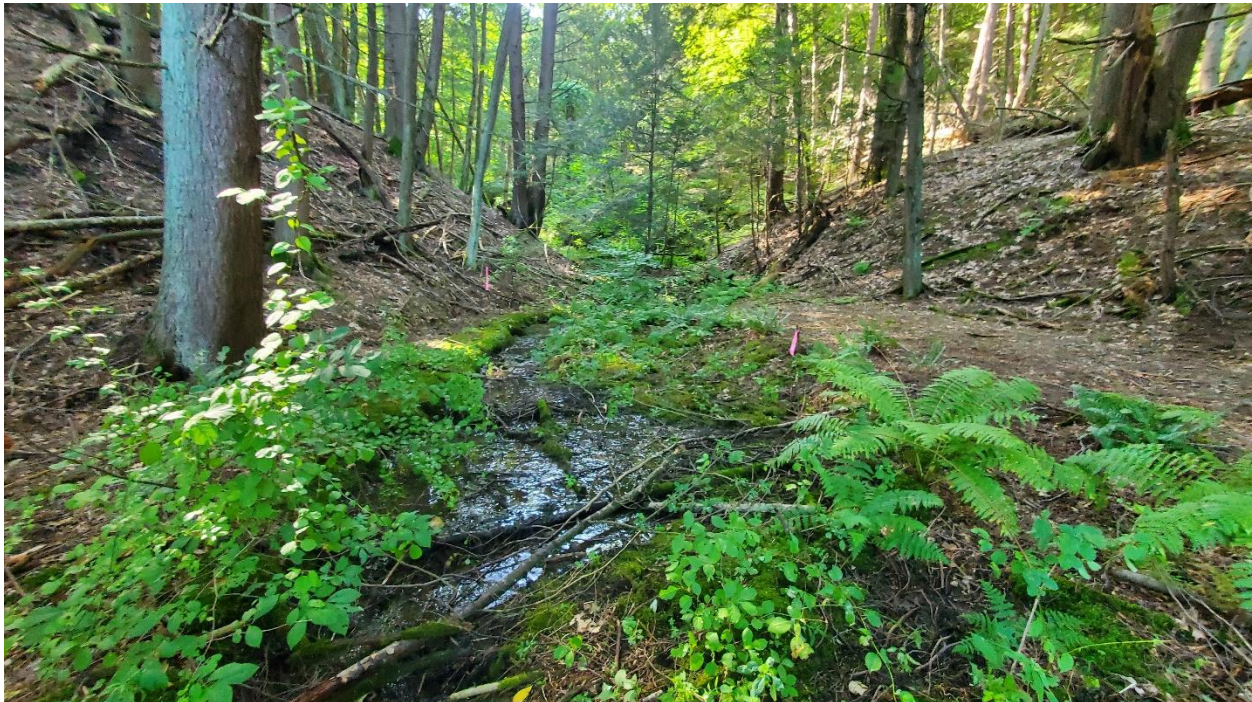
**Photo 11.** At center, a drainage swale that is an extension of the BVW located north of Elmer Brook (flag series D400-D414 and E500-E505). The swale conveys surface water into the delineated area between flags D414 and E500. Looking northwest near flag E501.

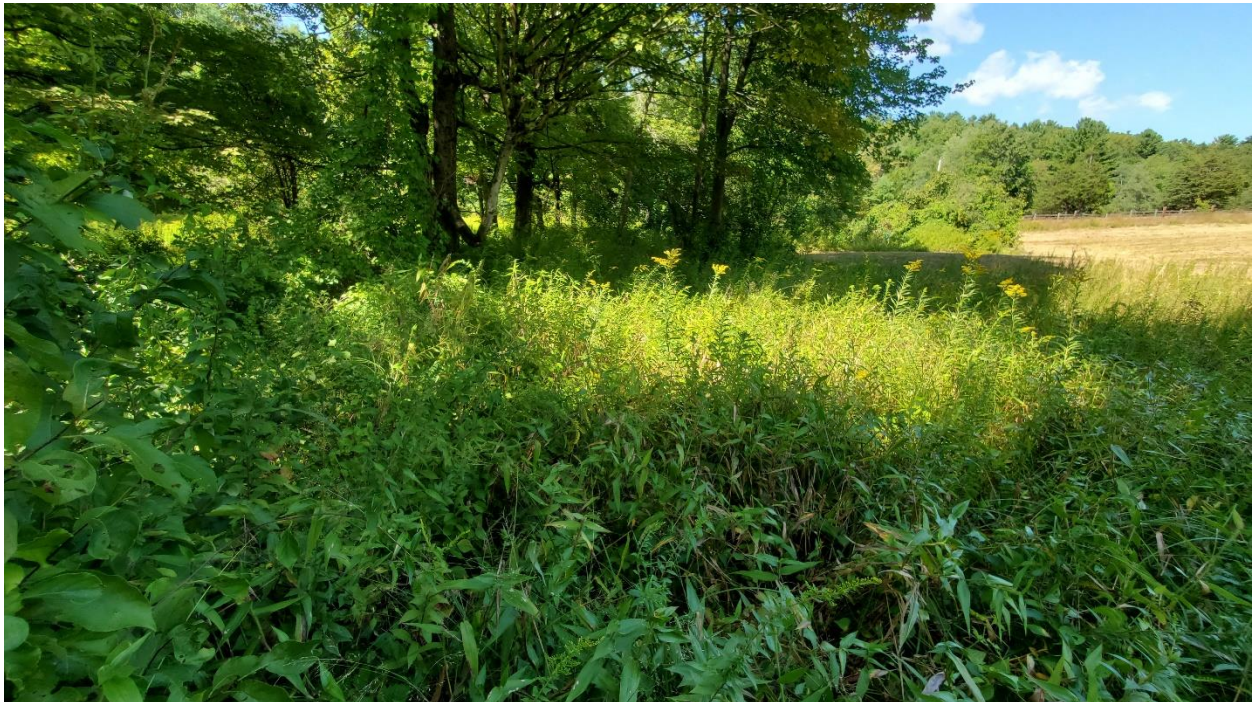
**Photo 13.** Floodplain located along the river-right, or eastern, bank of Elmer Brook south of Pearl Street. Looking north near flag C333.

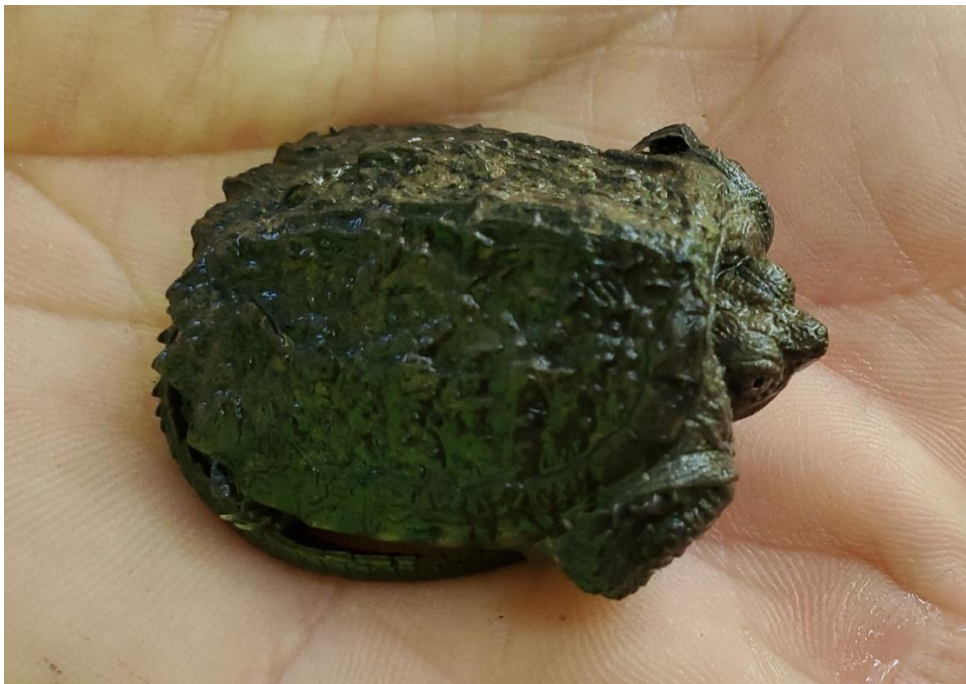
**Photo 14.** Hatchling of a snapping turtle (*Chelydra serpentina*), observed swimming downstream in Elmer Brook near flag A109.
