## Massachusetts Inland Resource Area Delineation Report

**Prepared For:** Town of South Hadley, Massachusetts  
116 Main Street  
South Hadley, MA 01075

**Project number:** 20170390.V30

**Site Address/Location:** Titus Pond, and Buttery Brook to daylighted reach located below Joffre Avenue  
42.233578° N, -72.585406°W

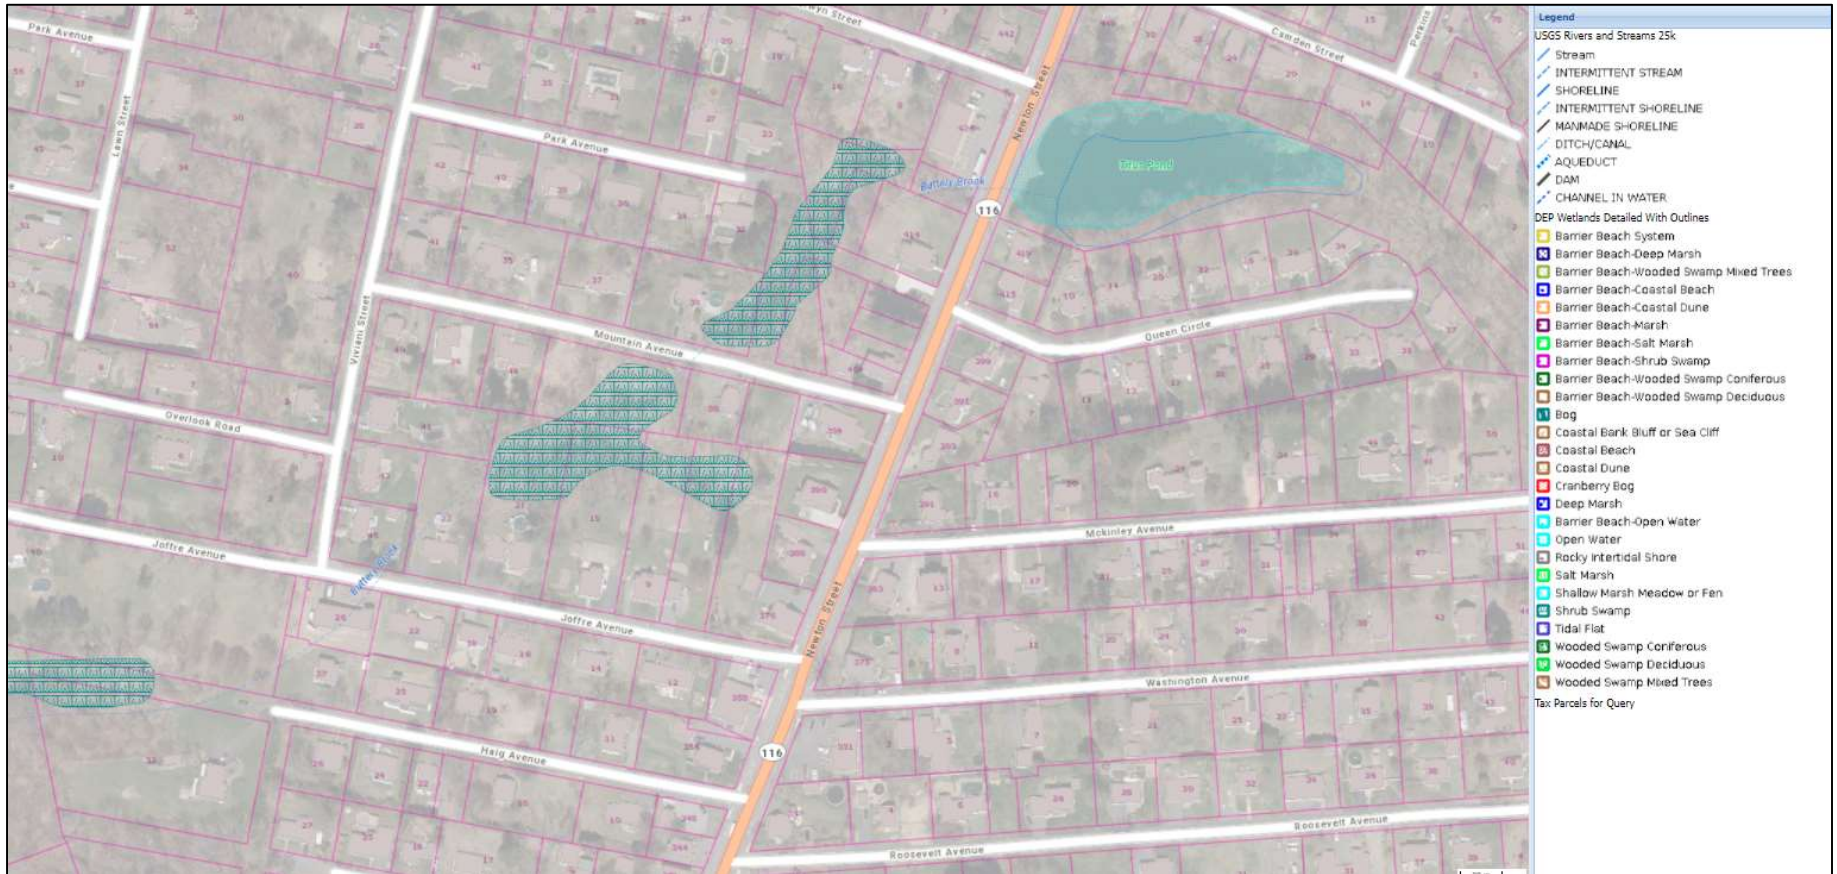
## **Resource Areas Mapped by the State of Massachusetts**

Image obtained from MassGIS OLIVER ([http://maps.massgis.state.ma.us/map\\_ol/oliver.php](http://maps.massgis.state.ma.us/map_ol/oliver.php)) on 10/29/2021.

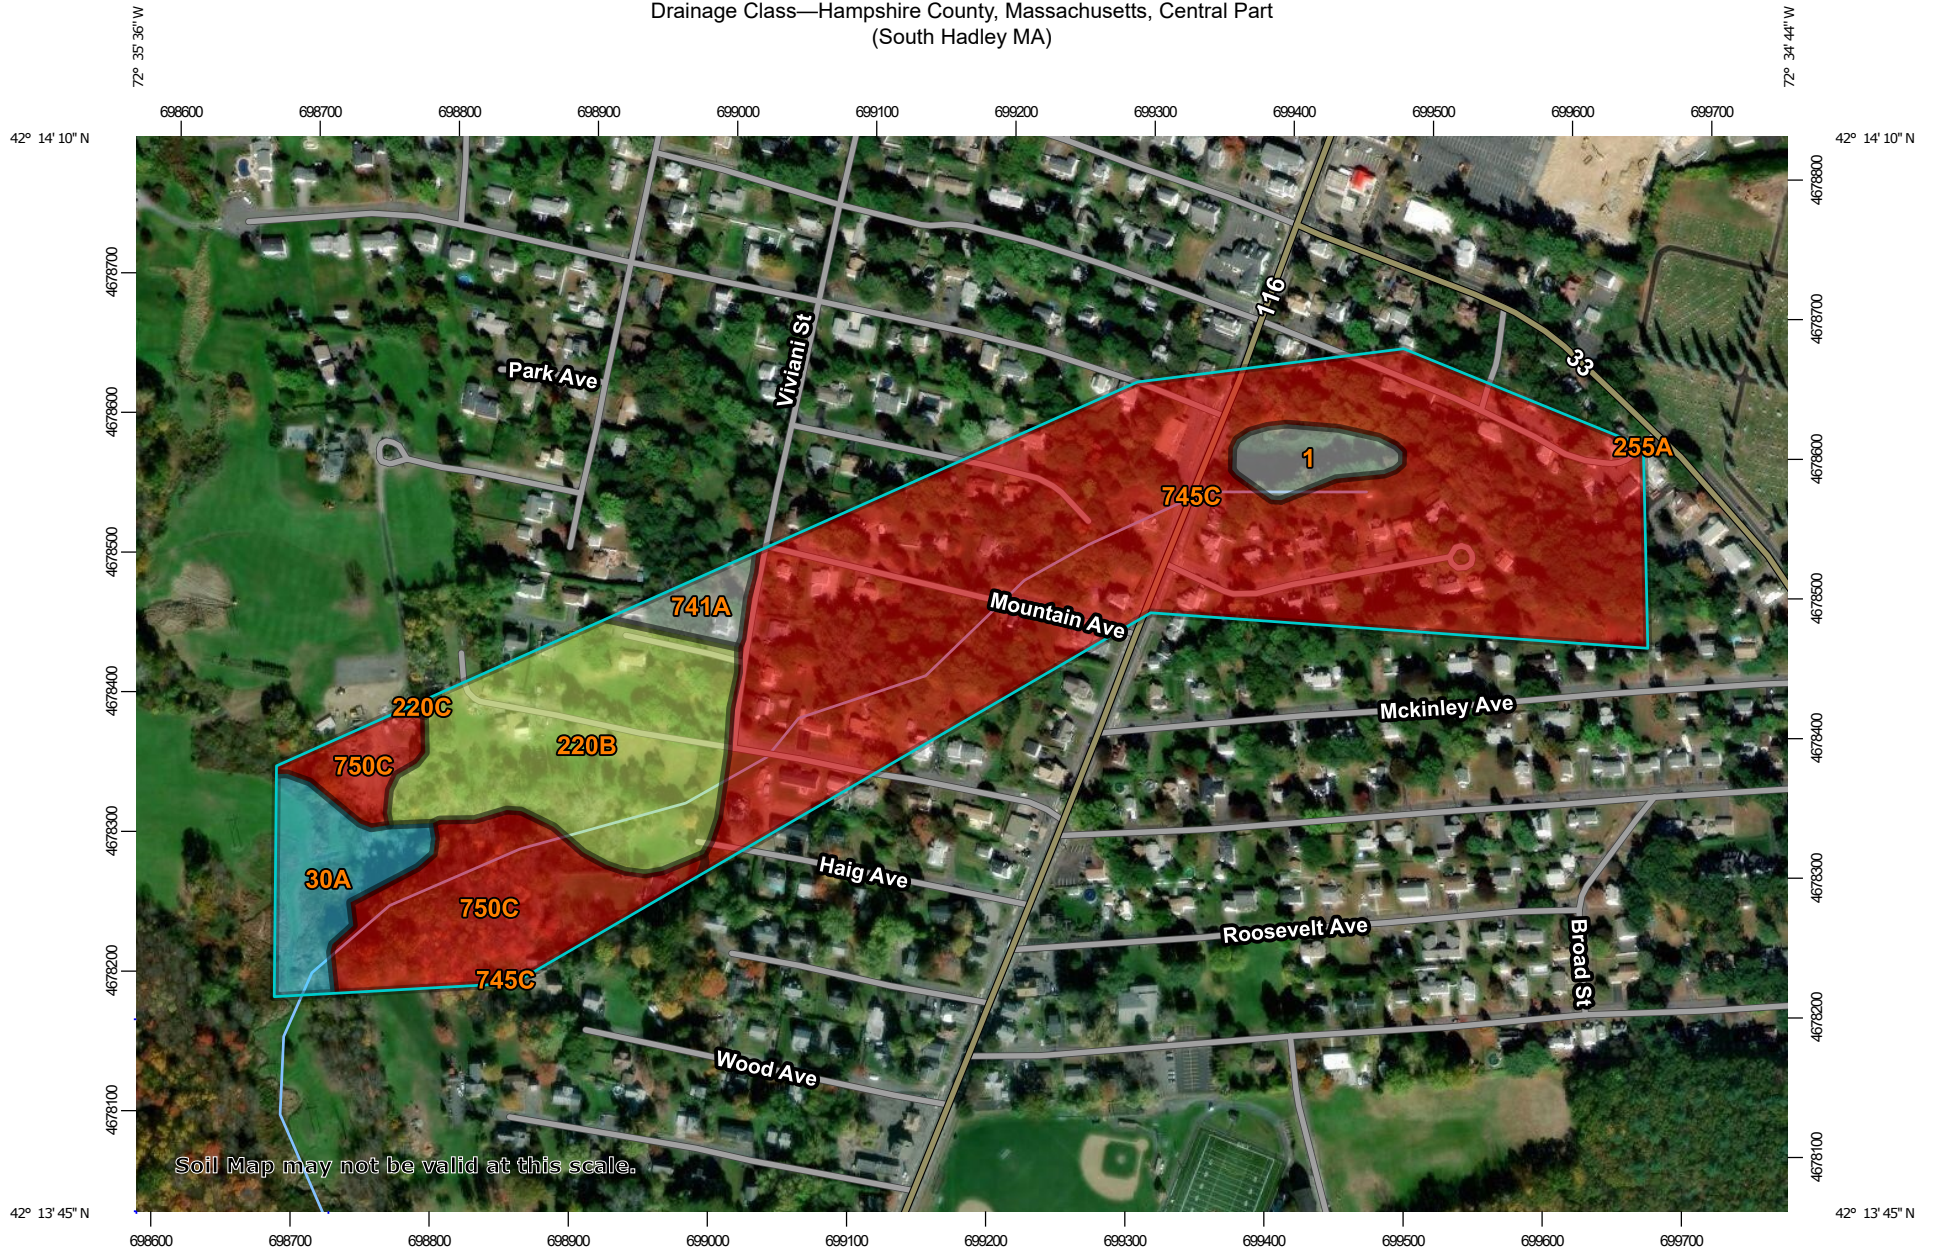
Drainage Class—Hampshire County, Massachusetts, Central Part  
(South Hadley MA)

Soil Map may not be valid at this scale.

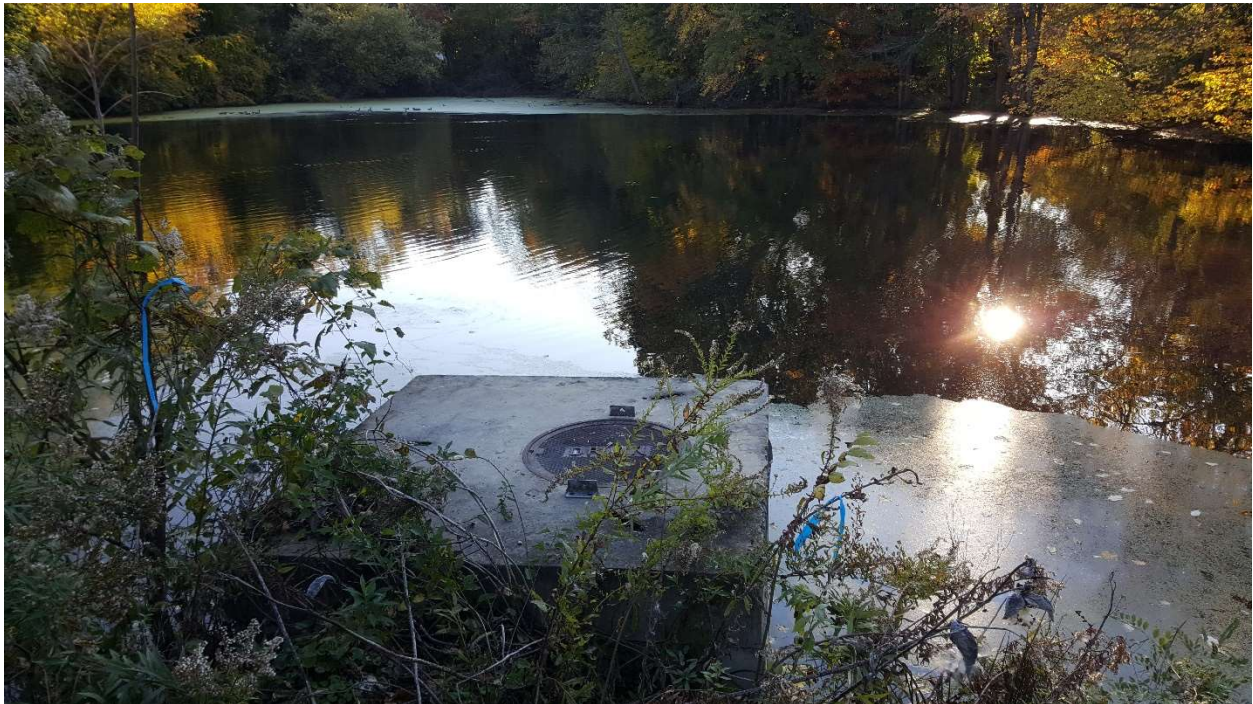
**Figure 1.** Titus Pond, with the inlet control structure to Buttery Brook in the foreground. Looking east-northeast near flag A101.

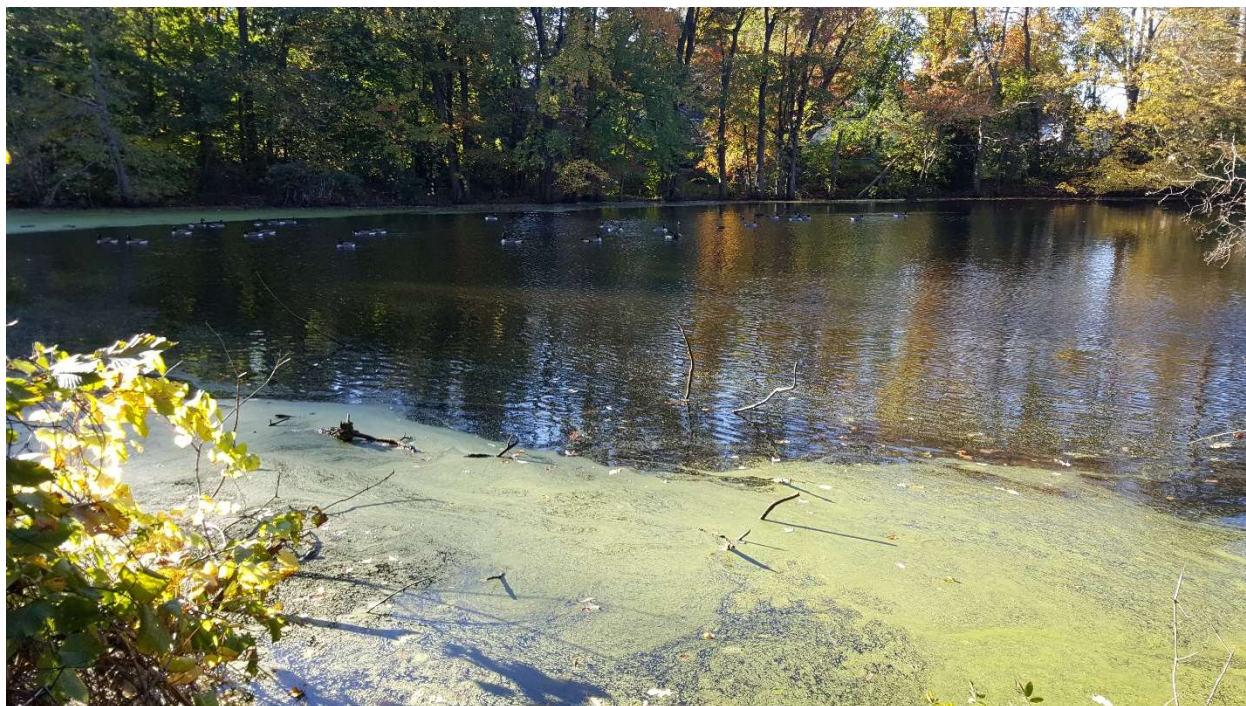
**Figure 3.** Titus Pond. Looking southwest near flag A113.

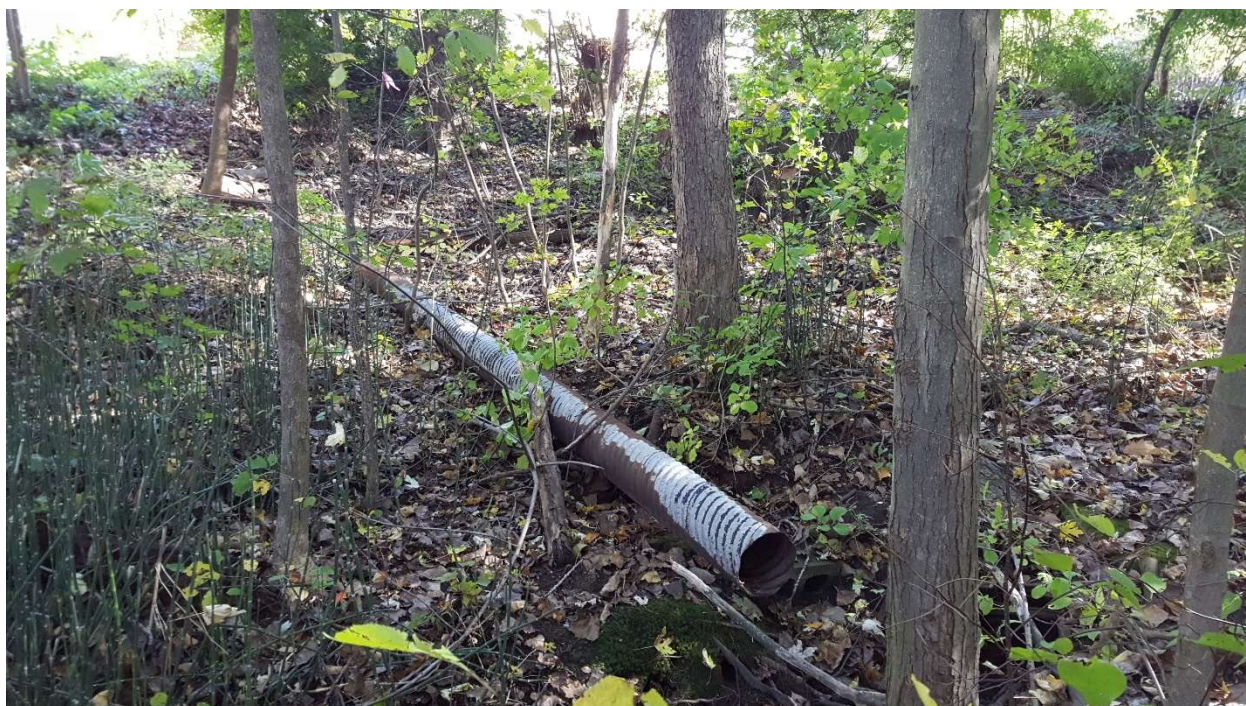
**Figure 4.** 8-inch corrugated metal pipe, presumably a stormwater outfall, within the BVW along the northern bank of Titus Pond (flag series B200-B215). Looking north.

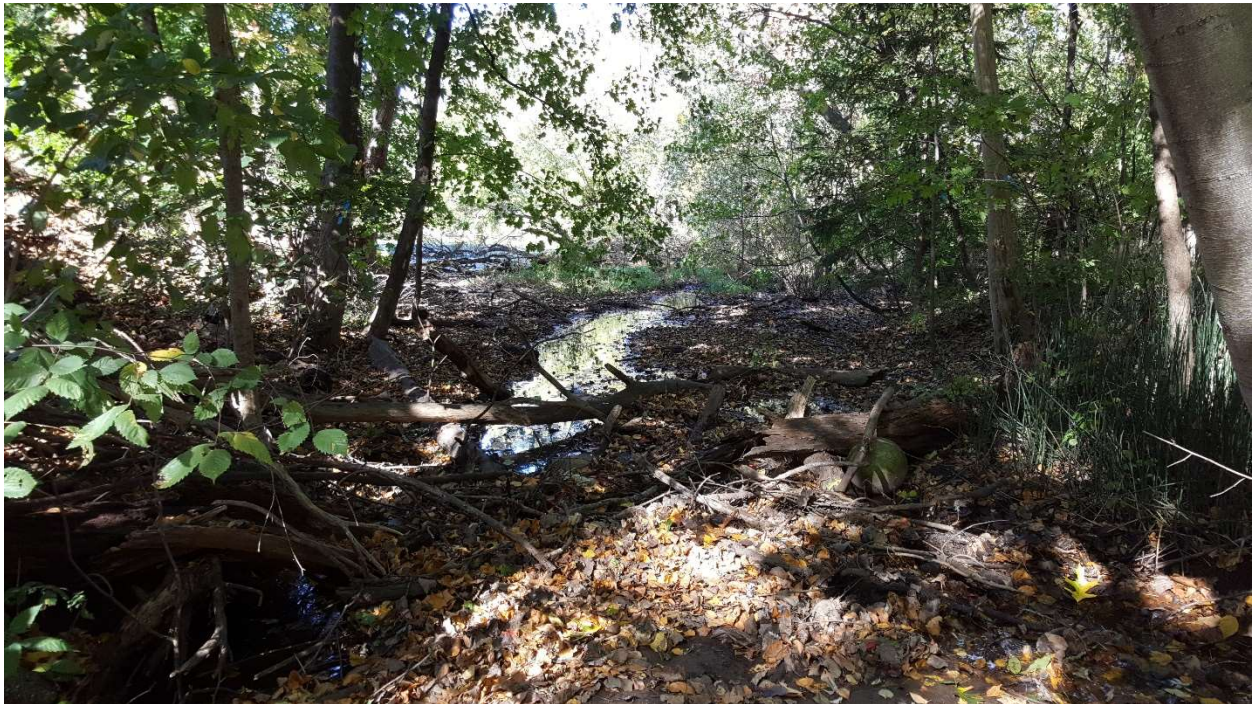
**Figure 5.** Lower reach of unnamed intermittent stream (flag series C300-C313 and D400-D411) flowing into Titus Pond, in background). Looking west-northwest (downstream) near flag D404.

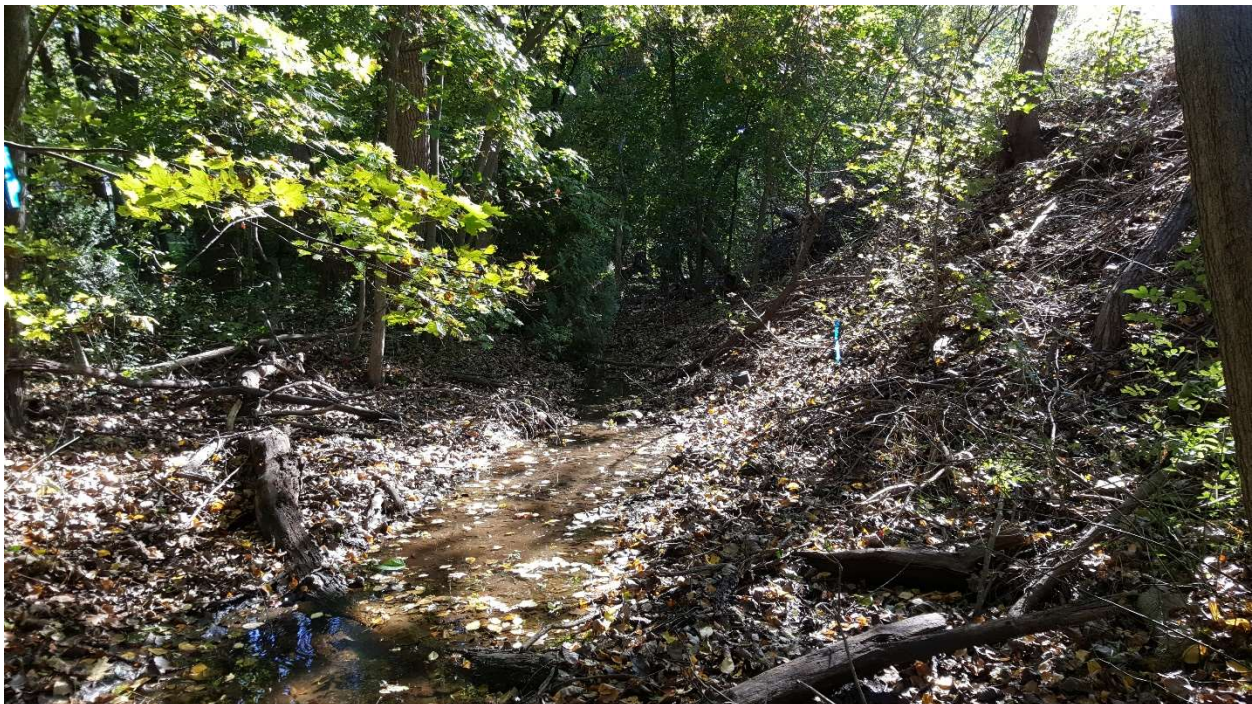
**Figure 6.** Lower reach of unnamed intermittent stream (flag series C300-C313 and D400-D411) flowing into Titus Pond, in background). Looking east-southeast (upstream) near flag D404.

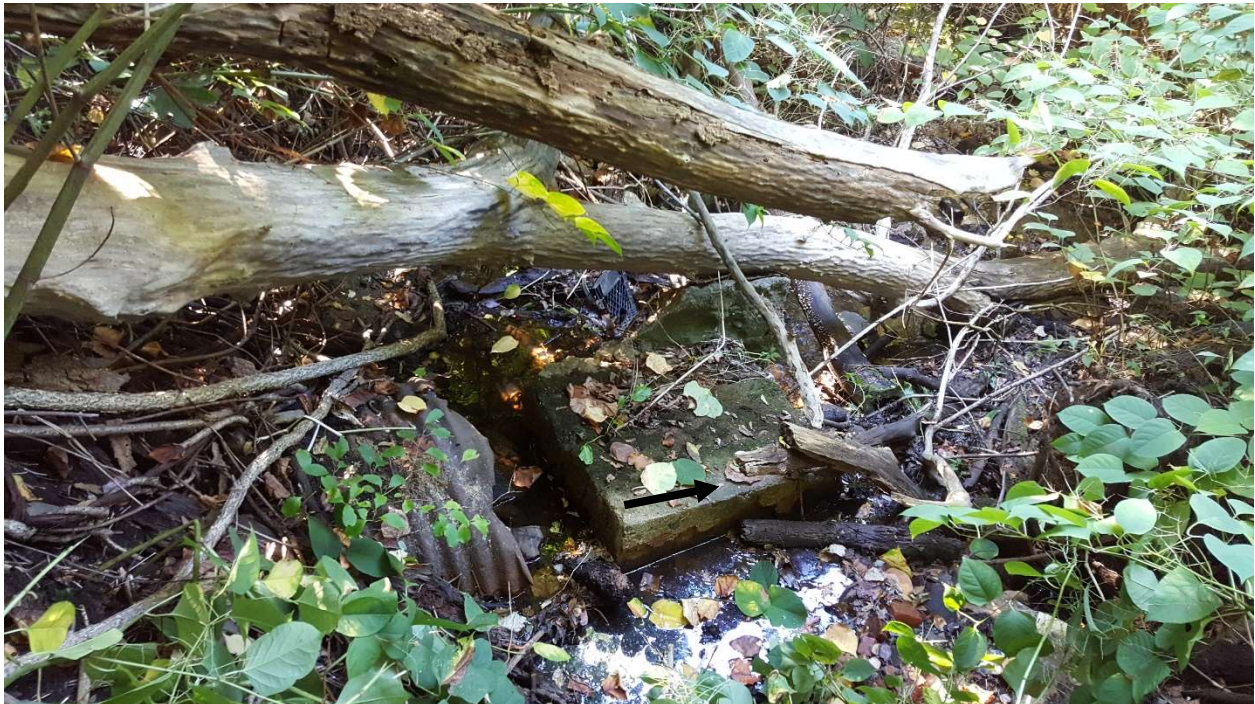
**Figure 7.** Corrugated metal pipe, which is the outlet of Titus Pond and the beginning of Buttery Brook. Outlet is perched and severely deteriorated. Arrow indicates flow direction. Looking east near flag E501.

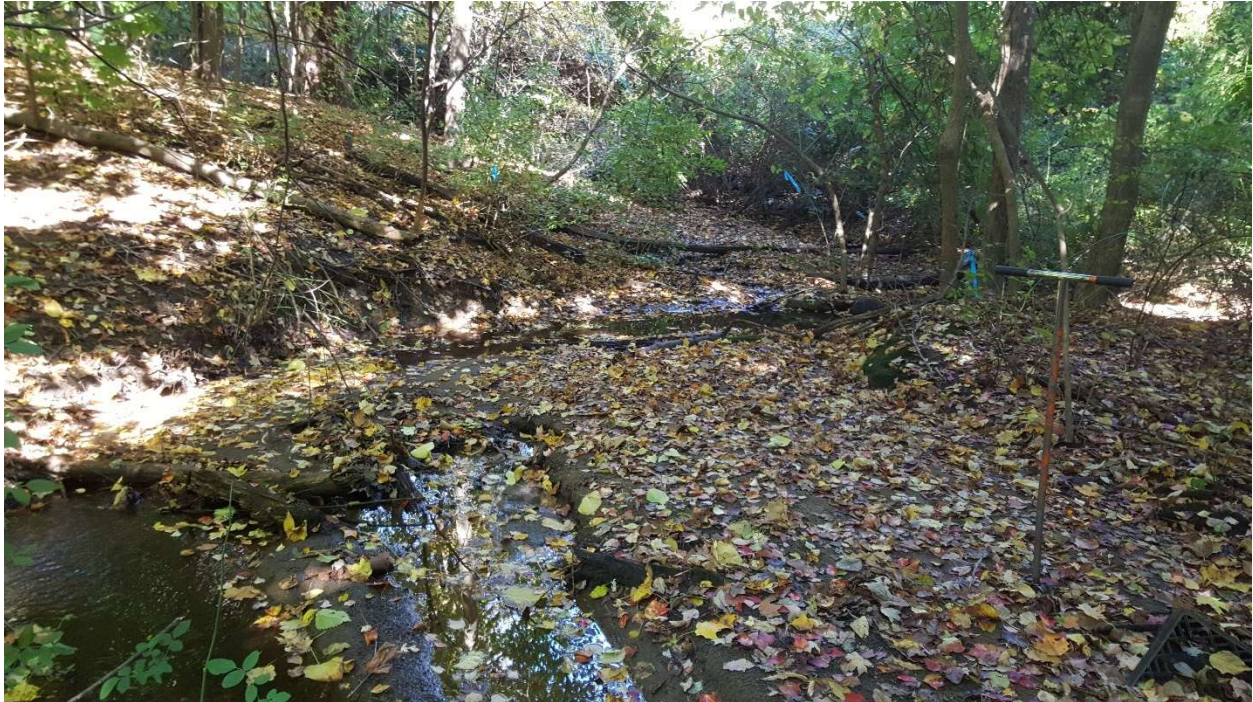
**Figure 9.** Buttery Brook, with BVW at right and in background at left (flag series Q700-Q702 and P600-P613, respectively). Looking northeast (upstream) near flag F610.

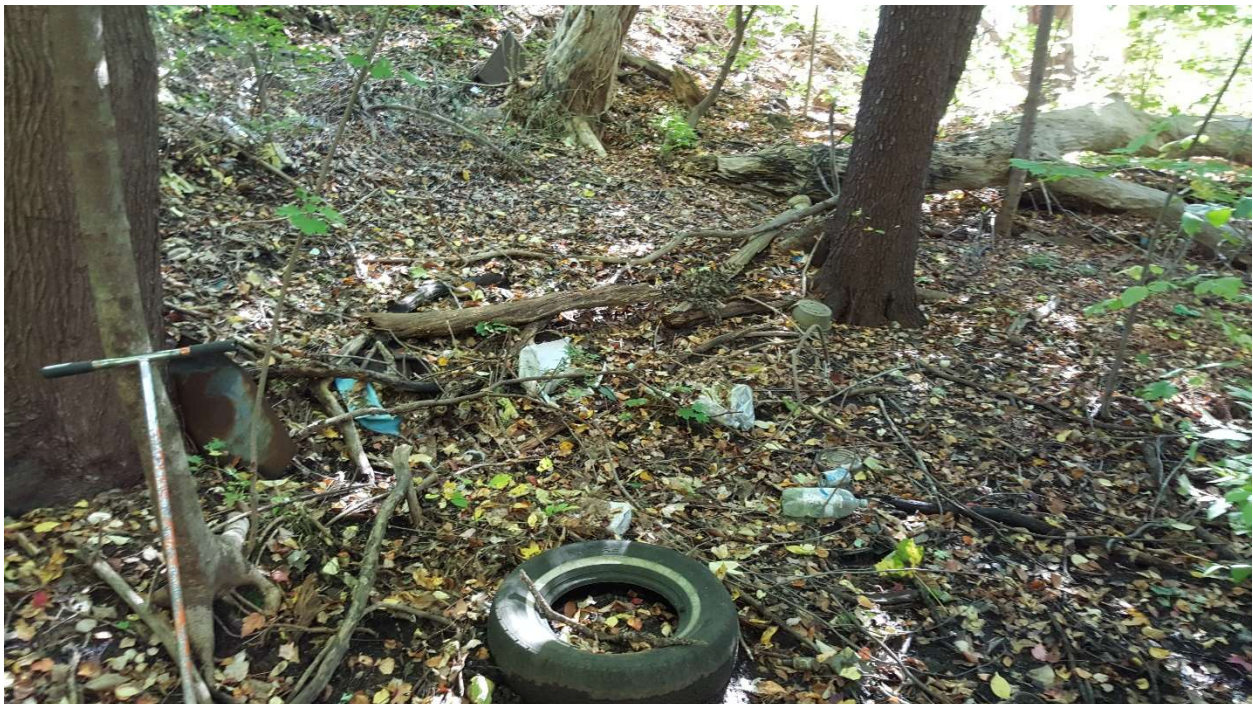
**Figure 10.** Section of debris observed in BVW east of Buttery Brook (flag series R800-R815). Looking south near flag E514.

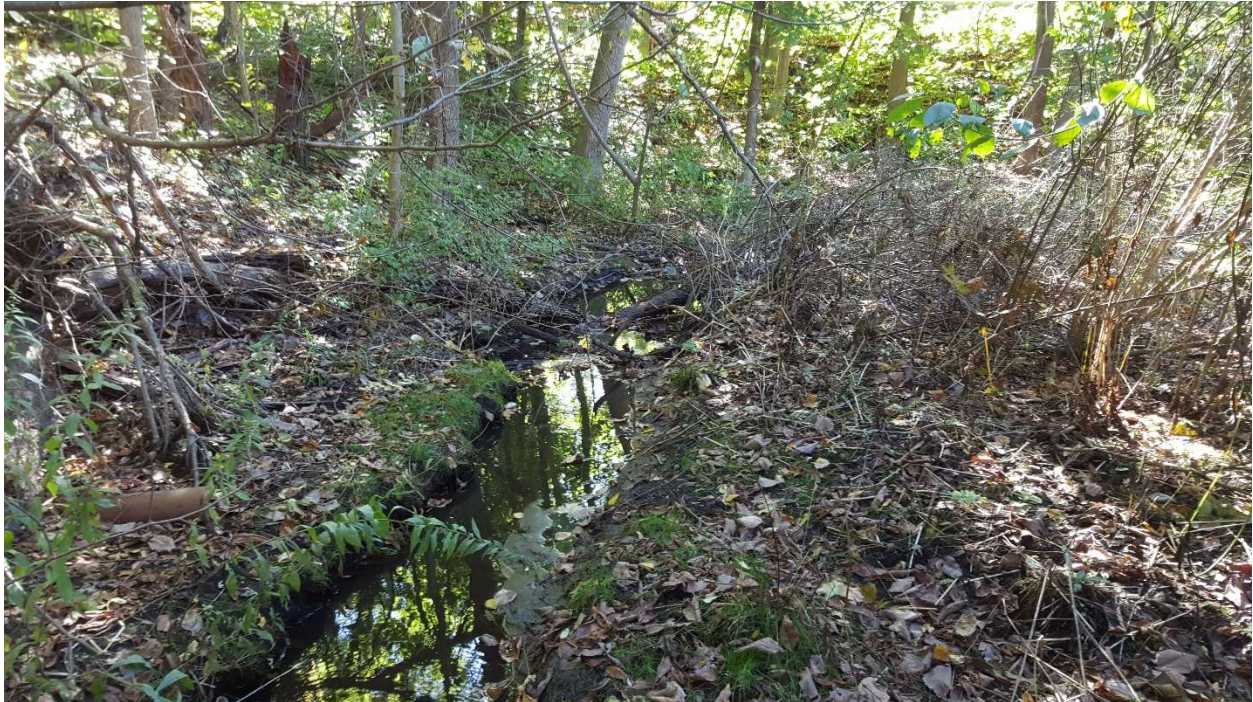
**Figure 11.** Buttery Brook, with BVW at right and left (flag series N500-N514 and R800-R815, respectively). Looking south-southwest (downstream) near flag E525.

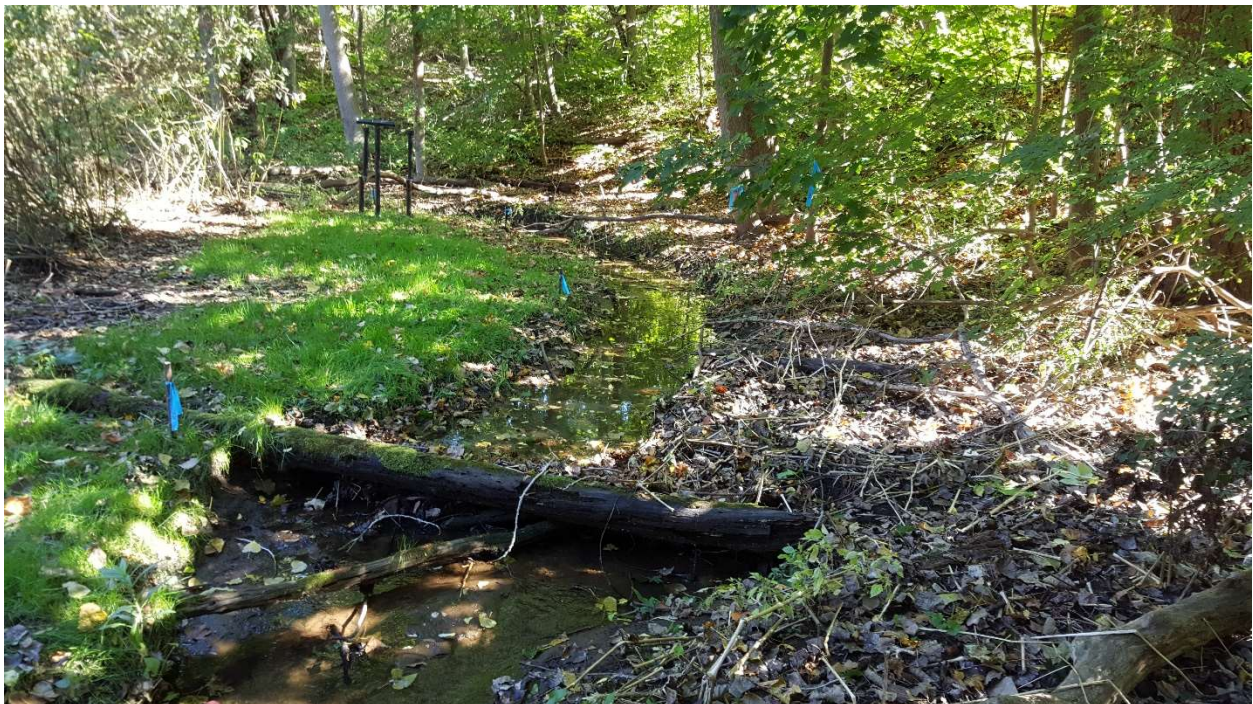
**Figure 12.** Buttery Brook, with BVW at right and left (flag series R800-R815 and N500-N514, respectively). Looking east (upstream) near flag F635.

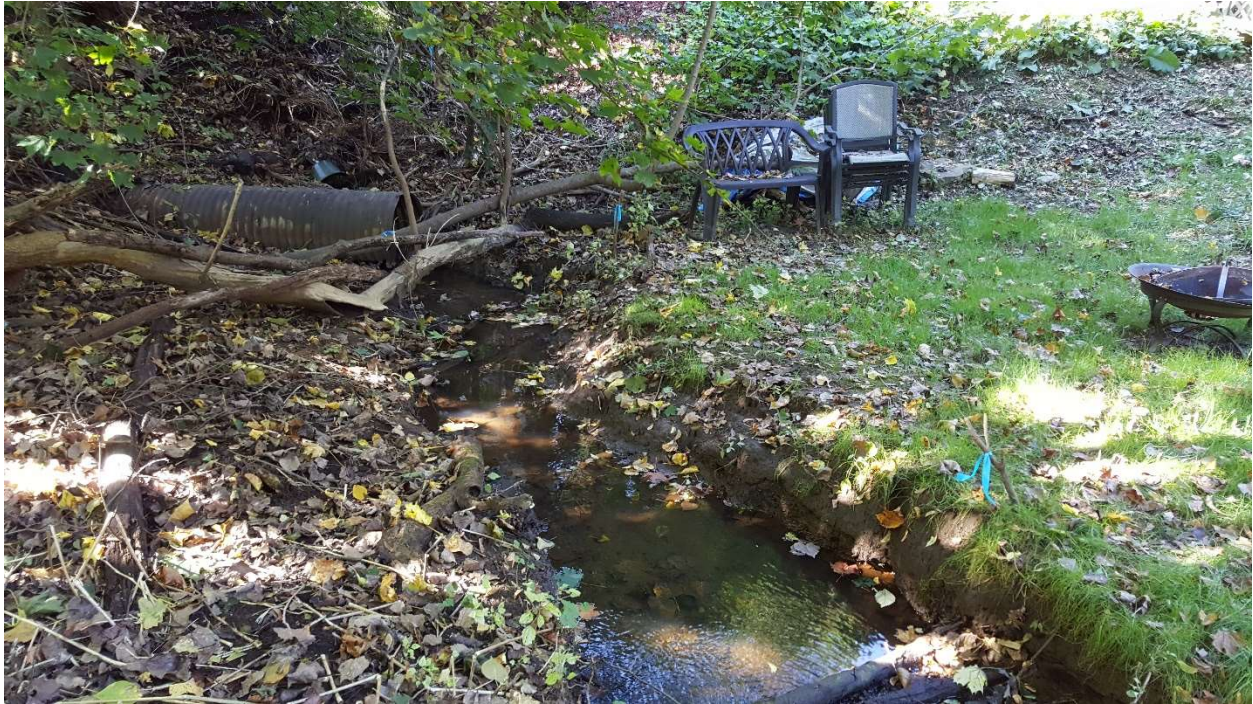
**Figure 13.** Buttery Brook at the inlet north of Mountain Avenue. BVW are at right and left (flag series N500-N514 and R800-R815, respectively). Looking west (downstream) near flag R814.

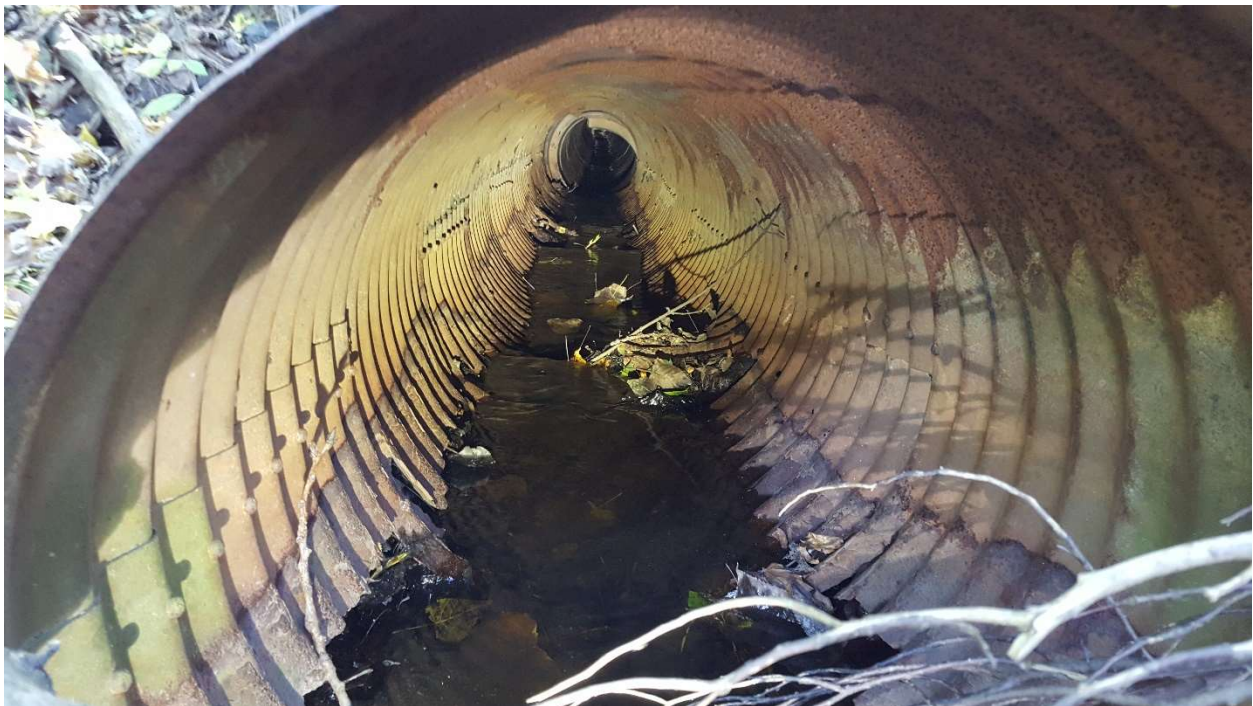
**Figure 14.** Deteriorated culvert conveying Buttery Brook under Mountain Avenue. Looking south-southwest from the inlet north of the road.

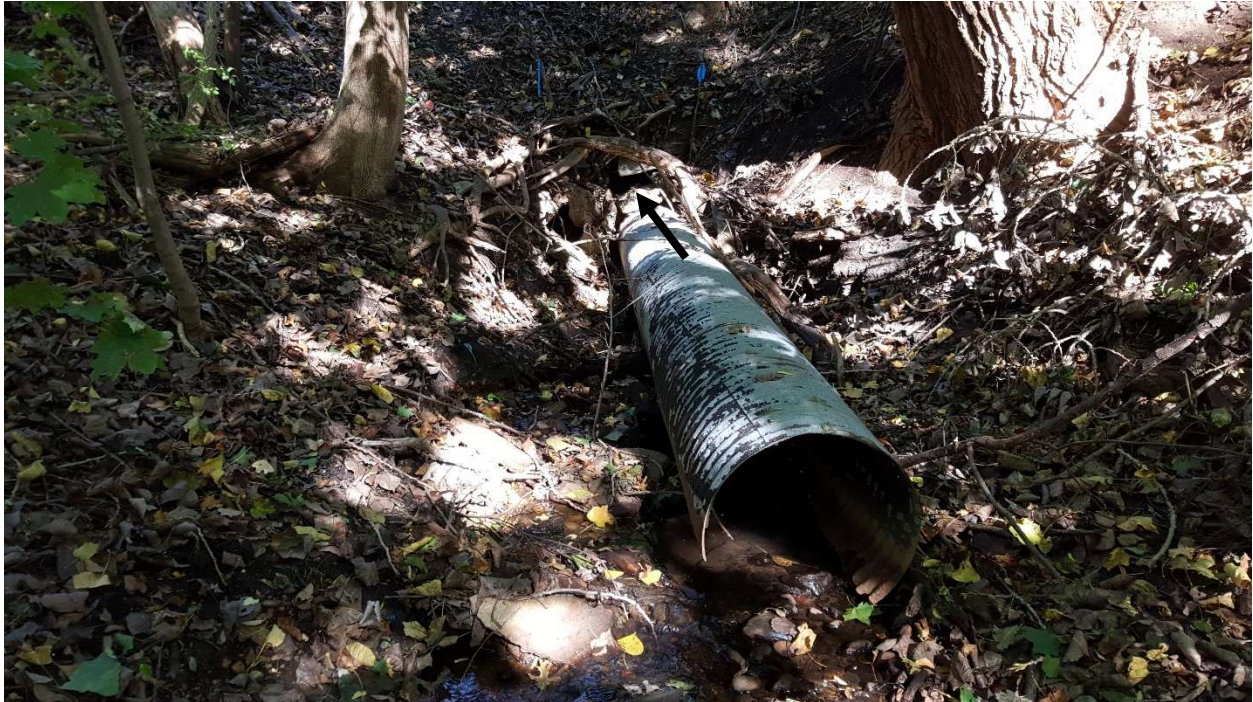
**Figure 15.** Outlet for Buttery Brook south of Mountain Avenue. Arrow indicates where majority of flow emerges from crossing, as pipe segments have separated. Looking northeast (upstream).

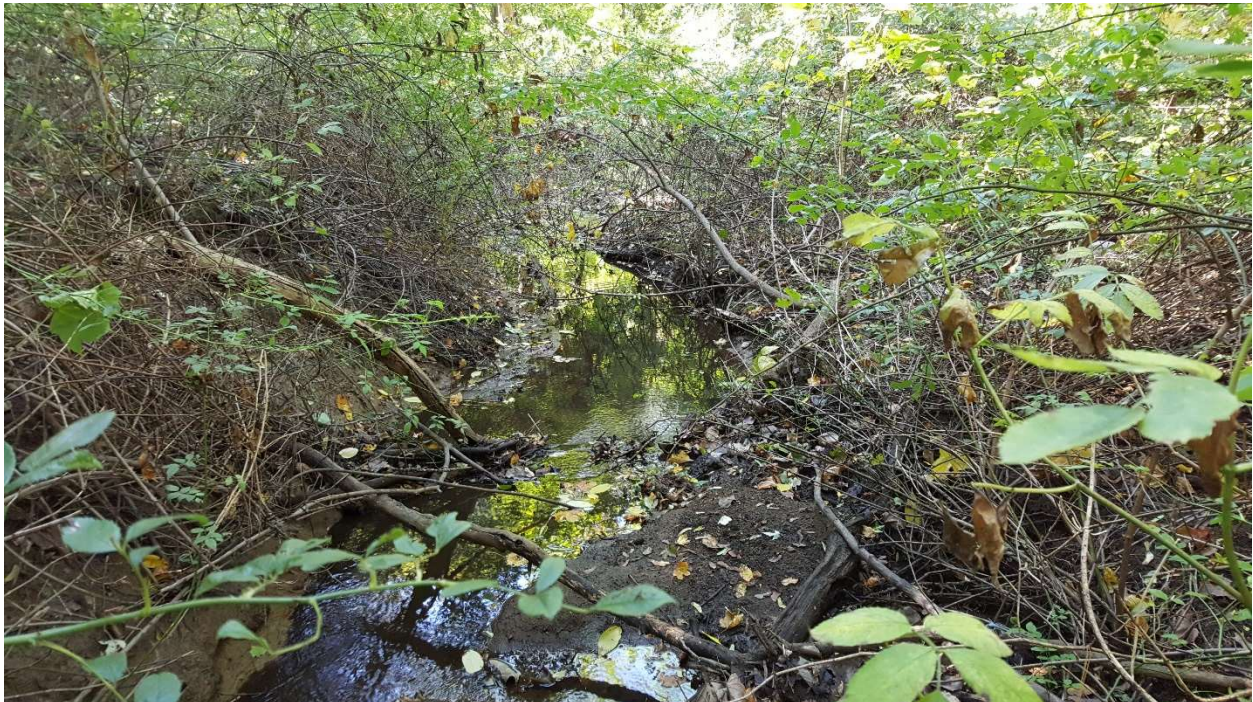
**Figure 16.** Buttery Brook, with BVW at right (flag series M400-M406). Looking southwest (downstream) near flag E537.

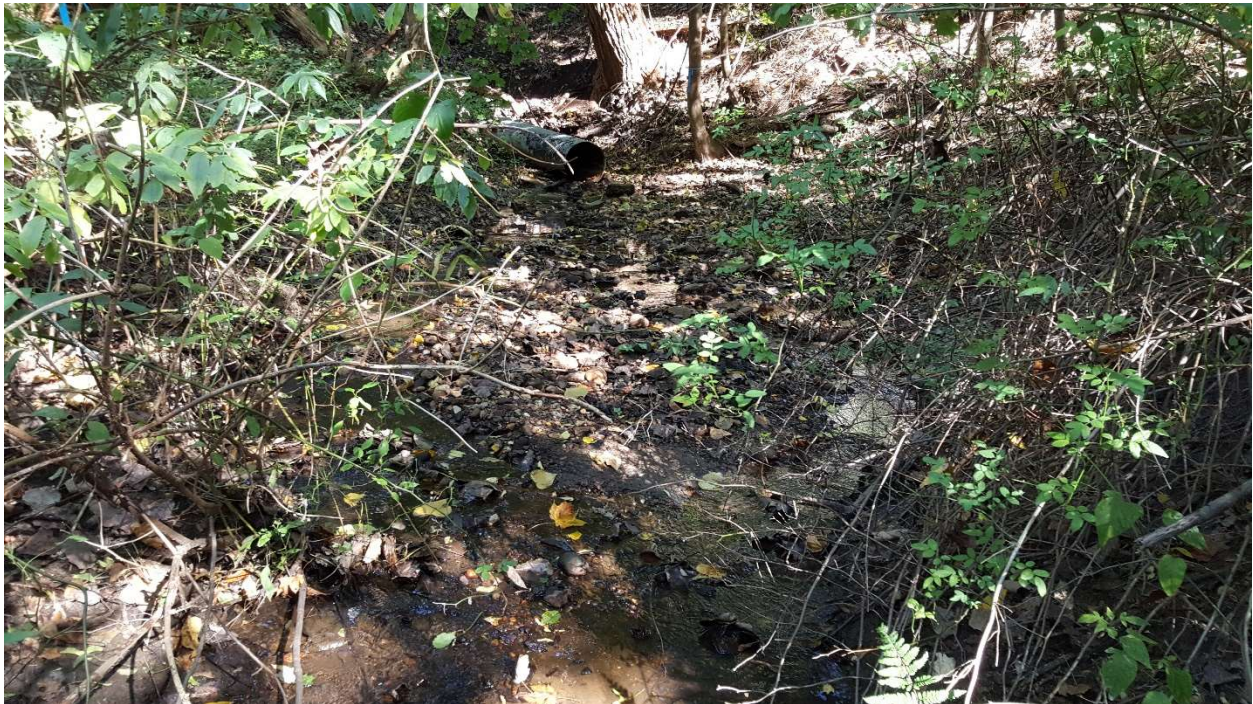
**Figure 17.** Buttery Brook, with BVW at left (flag series M400-M406). Outlet for the Mountain Avenue crossing is in the background. Looking northeast (upstream) near flag E537.

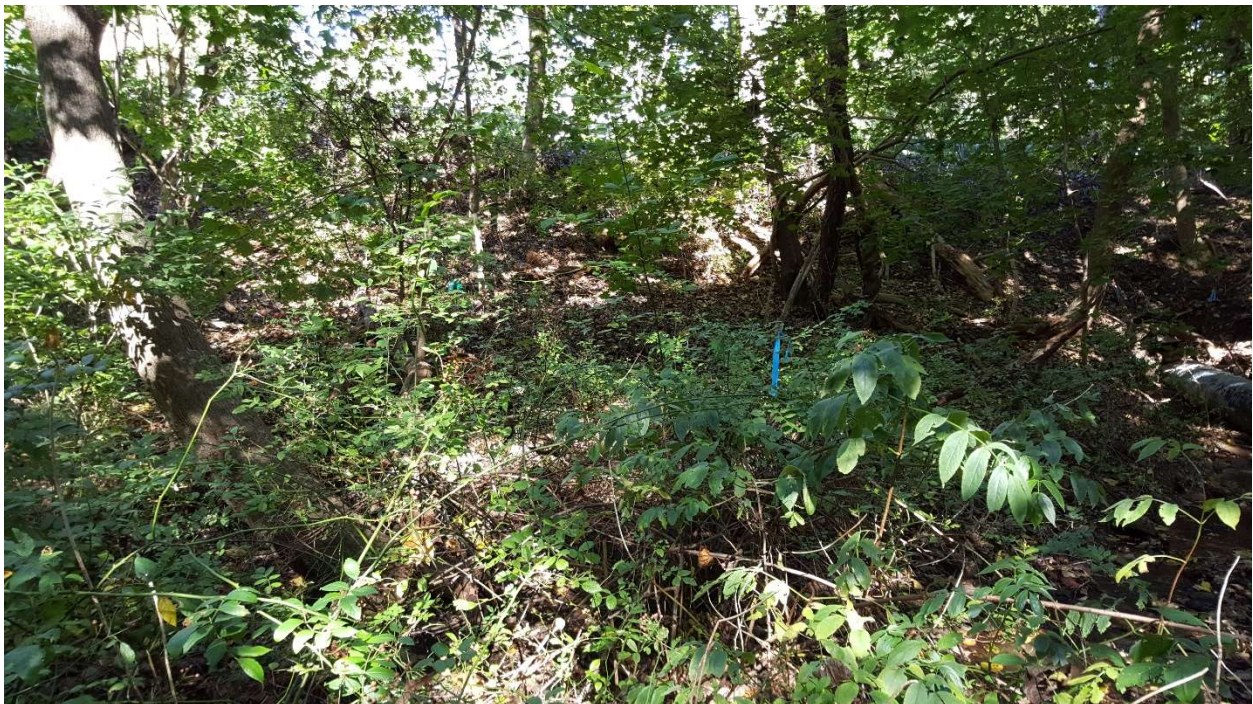
**Figure 18.** BVW (flag series M400-M406), with Buttery Brook in foreground. Looking northwest near flag E537.

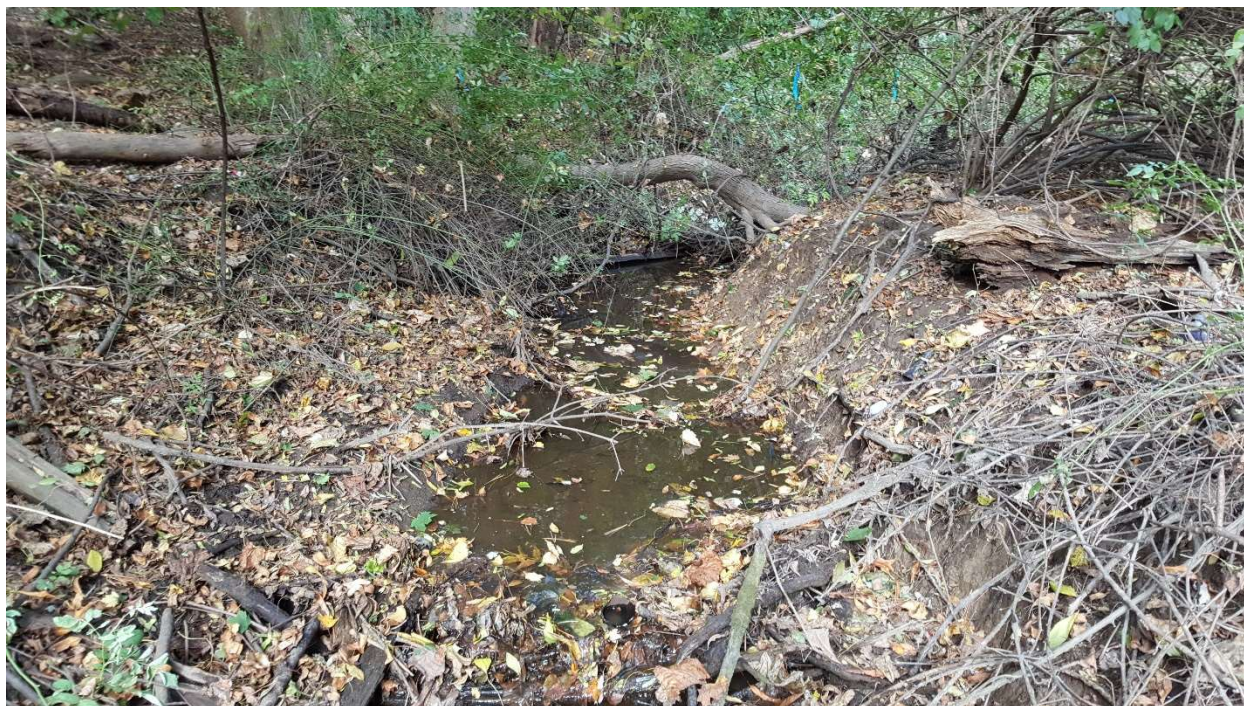
**Figure 19.** Buttery Brook. Looking northeast (upstream) near flag F649.

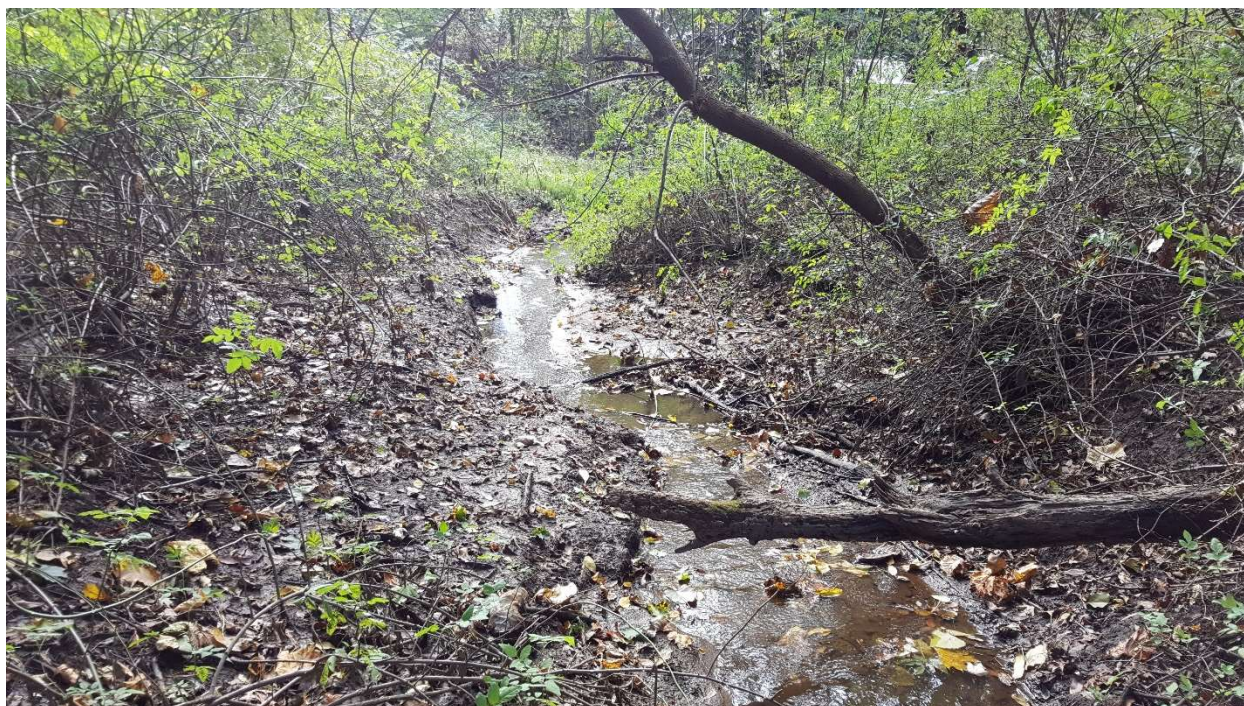
**Figure 20.** Buttery Brook, with BVW in background (flag series K200-K213). Looking southwest (downstream) near flag F649.

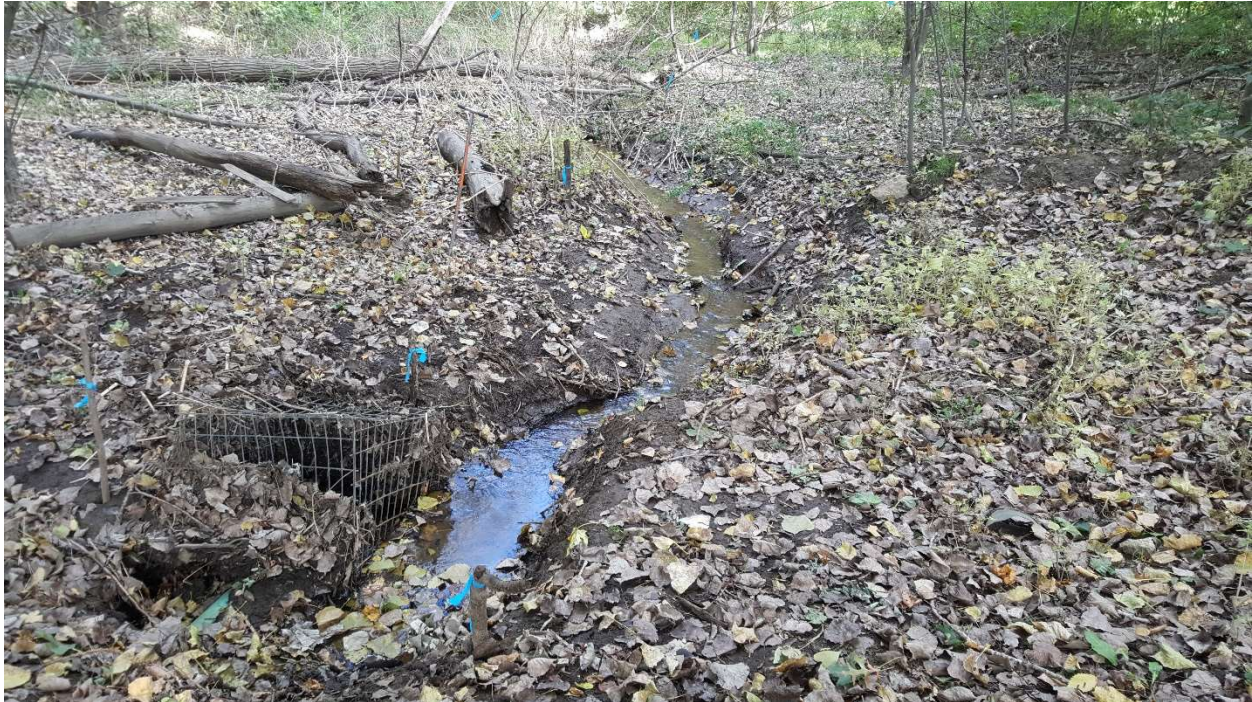
**Figure 21.** Buttery Brook and inlet to the buried reach under Joffre Avenue and surrounding area. BVW (flag series K200-K213) encircles the inlet and is visible at right and left. Looking northeast (upstream) near flag F656.

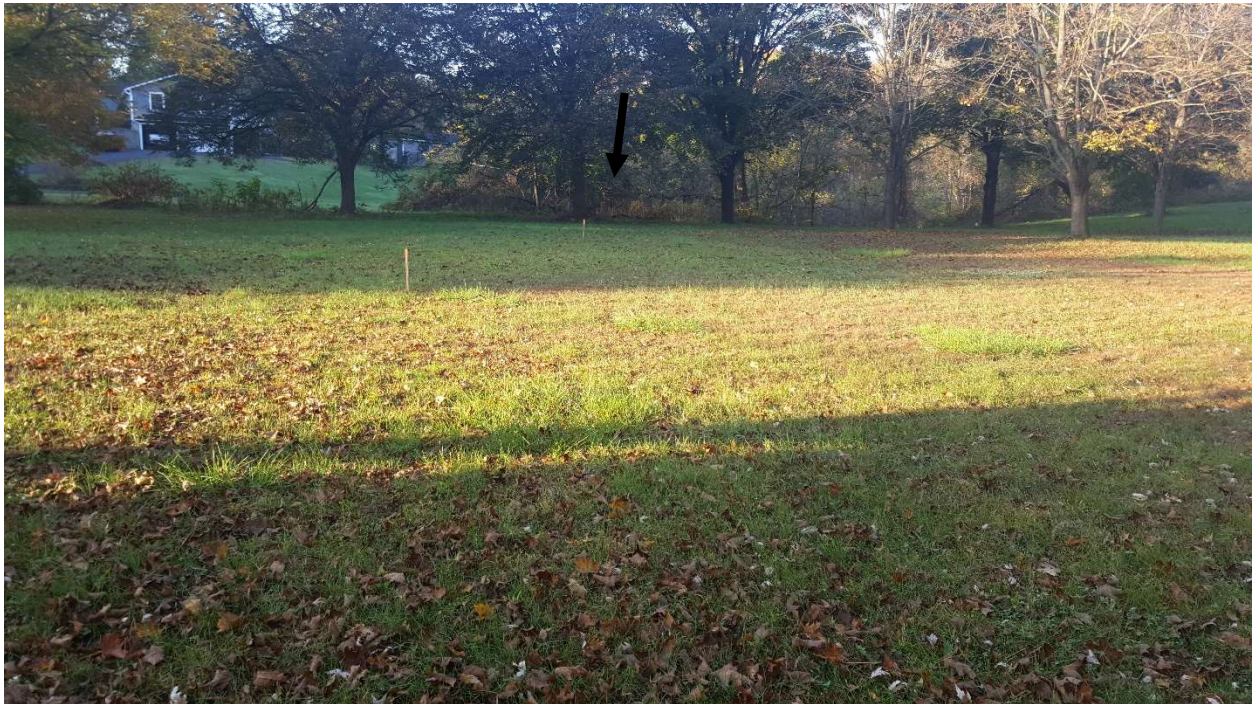
**Figure 23.** Approximate location of the buried reach of Buttery Brook under Joffre Avenue and surrounding area. Arrow indicates location of outlet. Looking southwest (downstream) south of Joffre Avenue
