## Massachusetts Inland Resource Area Delineation Report

**Prepared For:** Town of South Hadley, Massachusetts  
116 Main Street  
South Hadley, MA 01075

**Project number:** 20170390.V30

**Site Address/Location:** Titus Pond, and Buttery Brook to daylighted reach located below Joffre Avenue  
42.233578° N, -72.585406°W

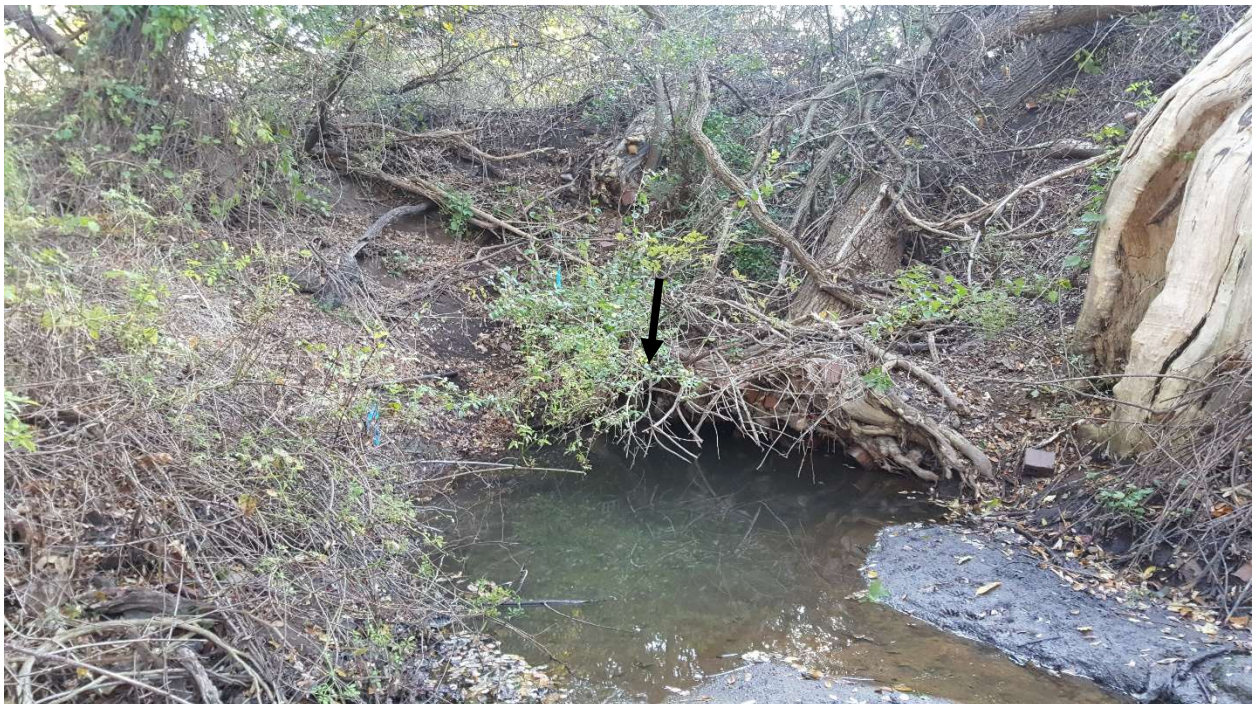
**Figure 24.** Outlet for Buttery Brook (flag series G700-G7-6 and H800-H812) south of Joffre Avenue. Outlet was almost entirely submerged and partially full of sediment. Looking east (upstream) near flag G702.

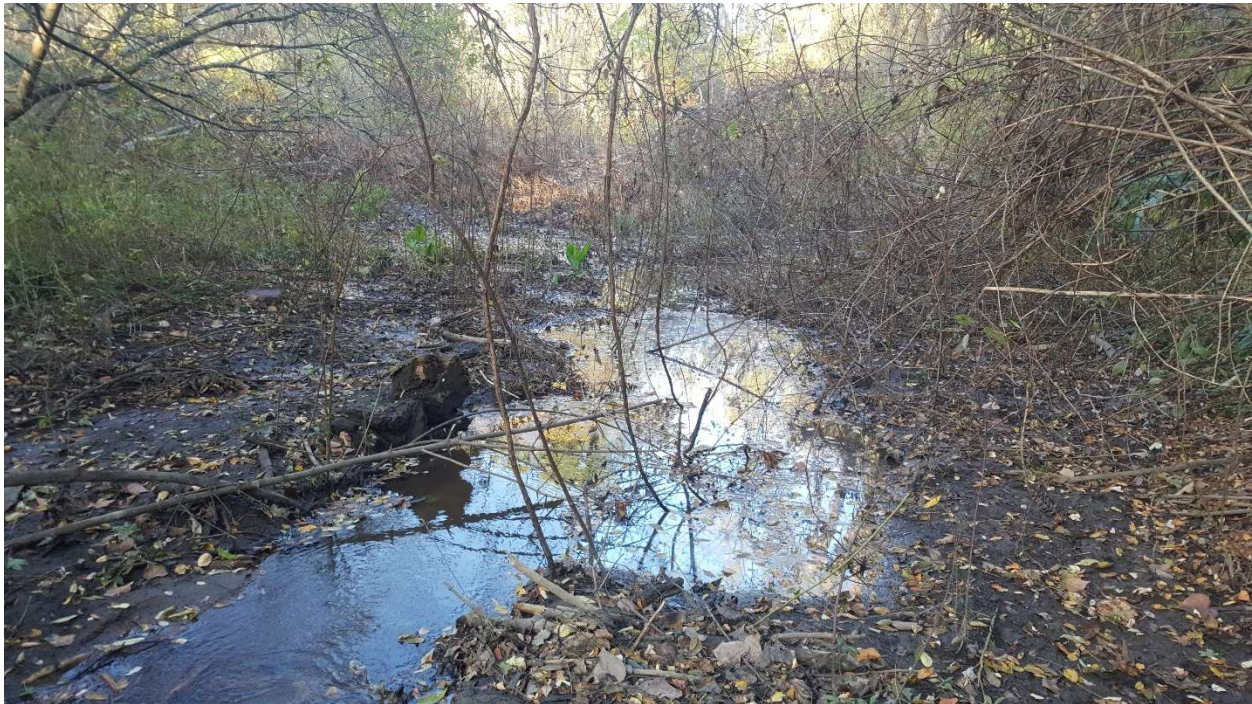
**Figure 25.** Buttery Brook, with BVW at right and left (flag series I900-I908 and J100-J107, respectively). Looking west (downstream) near flag G702.

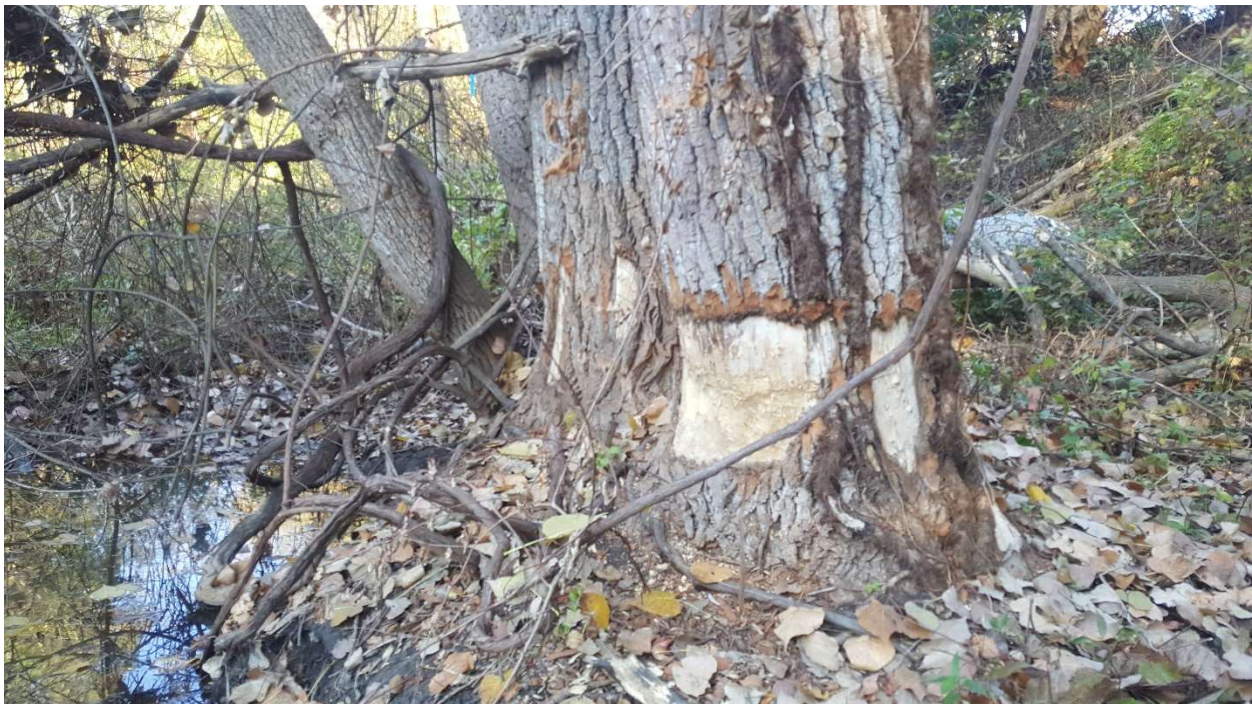
**Figure 26.** Girdling of mature eastern cottonwoods (*Populus deltoides*) by beaver (*Castor canadensis*), located in the BVW north of Buttery Brook (flag series (I900-I908). Looking east (downstream) near flag G705.

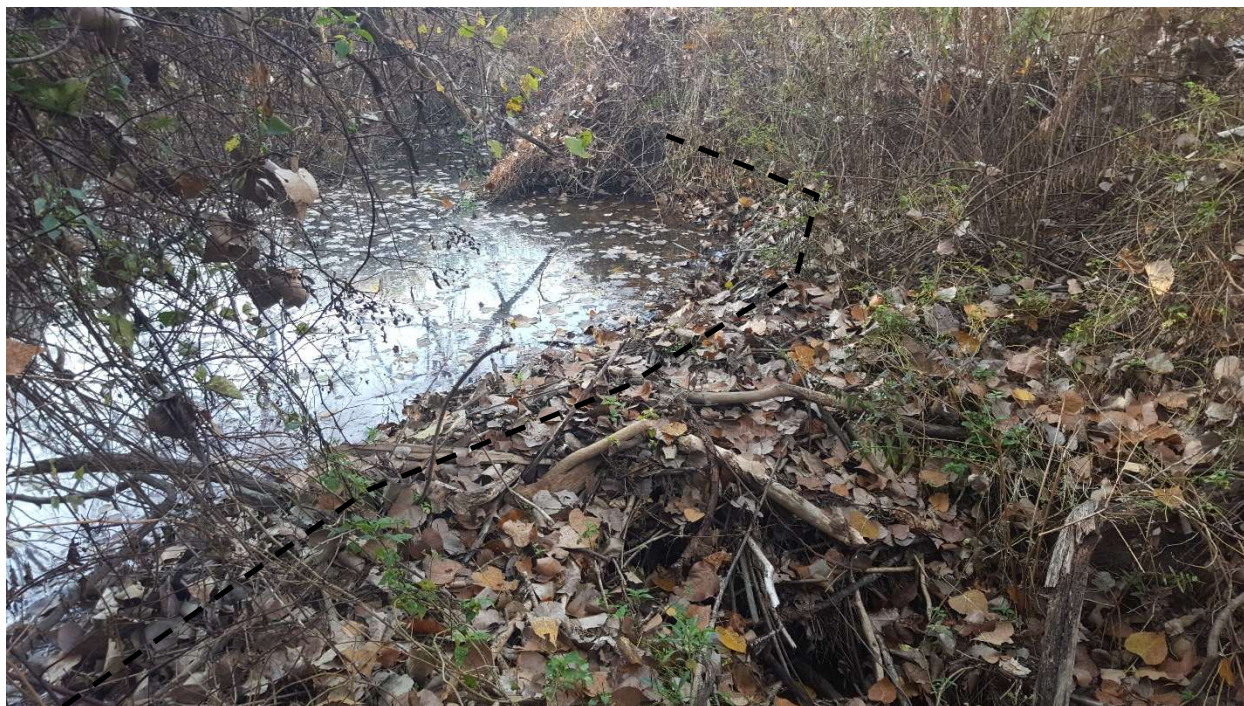
**Figure 27.** Beaver dam (dashed line). Looking south near flag G706)

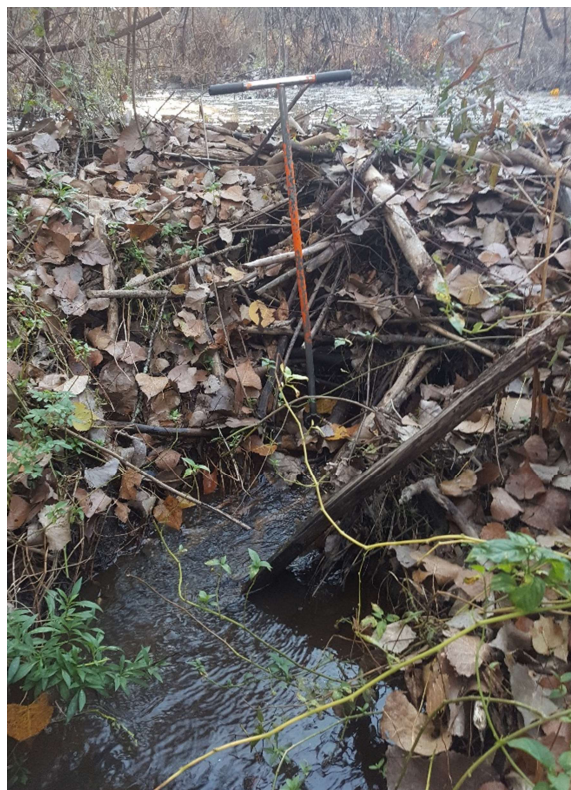
**Figure 28.** Buttery Brook downstream of the beaver dam. Looking east (upstream) near flag G707.

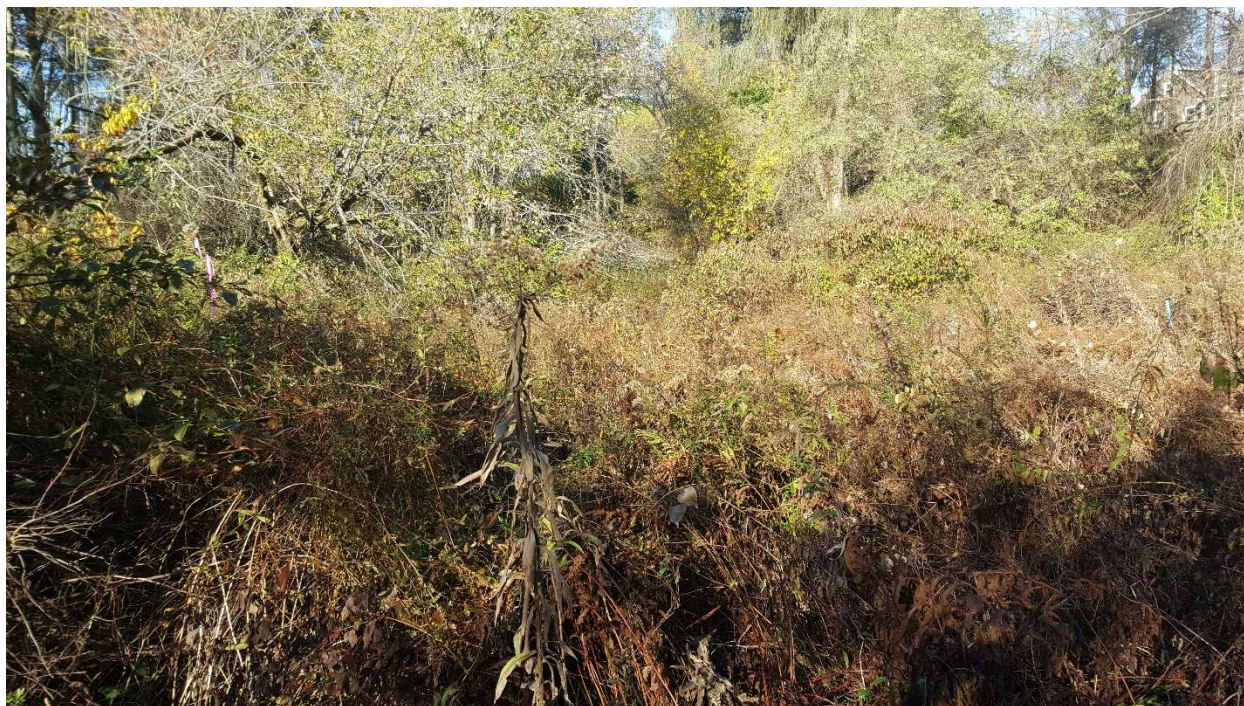
**Figure 29.** BVW south of Buttery Brook (flag series J100-J107). Looking west-southwest (downstream) near flag J105.

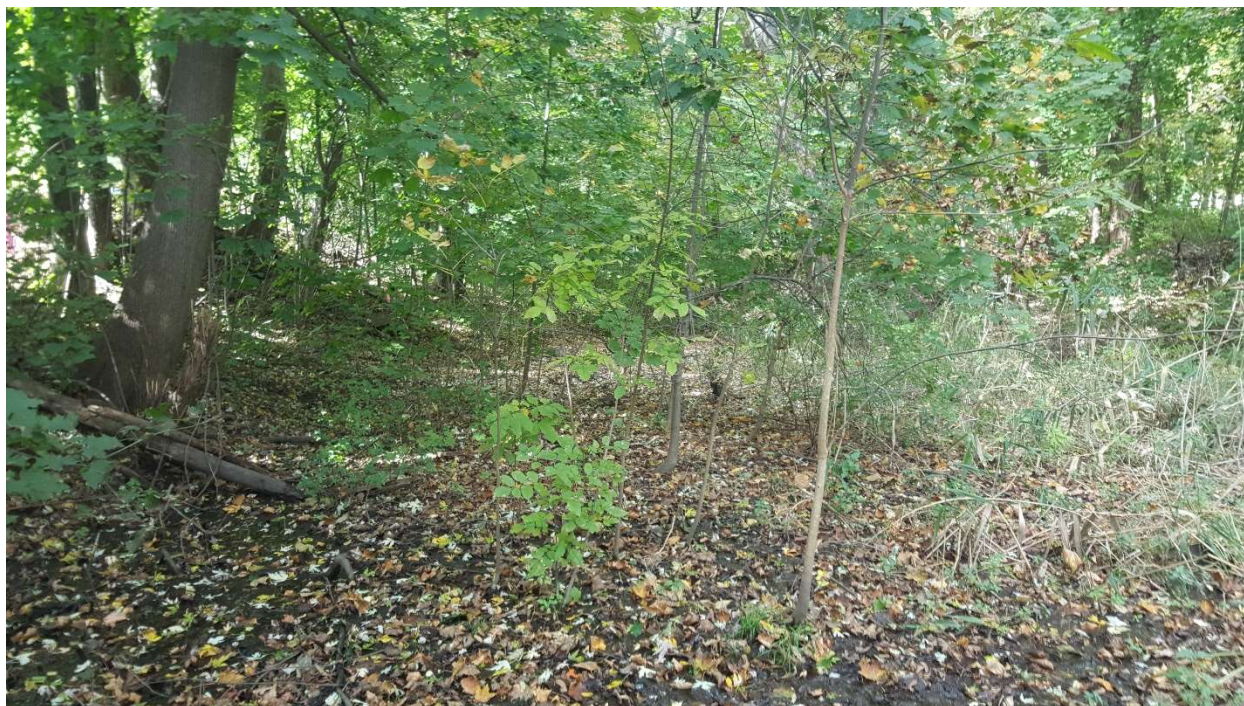
**Figure 30.** BVW south of Buttery Brook (flag series L300-L337). Looking west near flag L317.

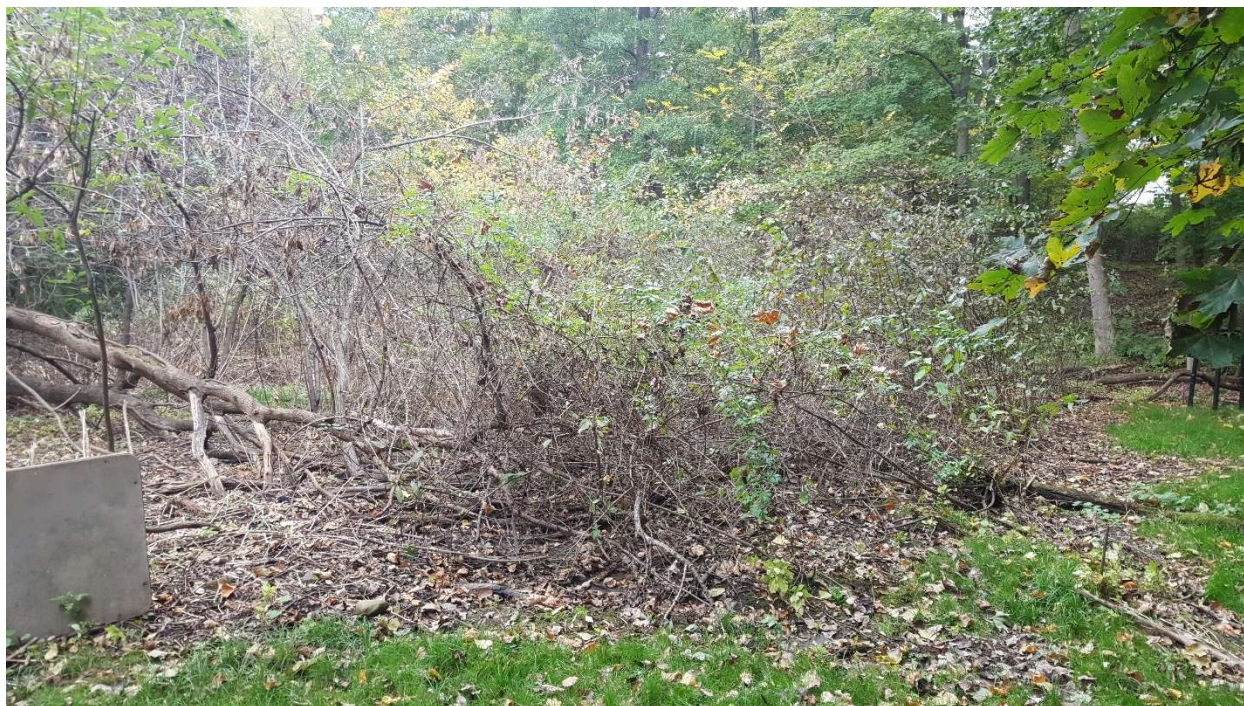
**Figure 31.** BVW west of Buttery Brook (flag series N500-N514). Looking north near flag N505.

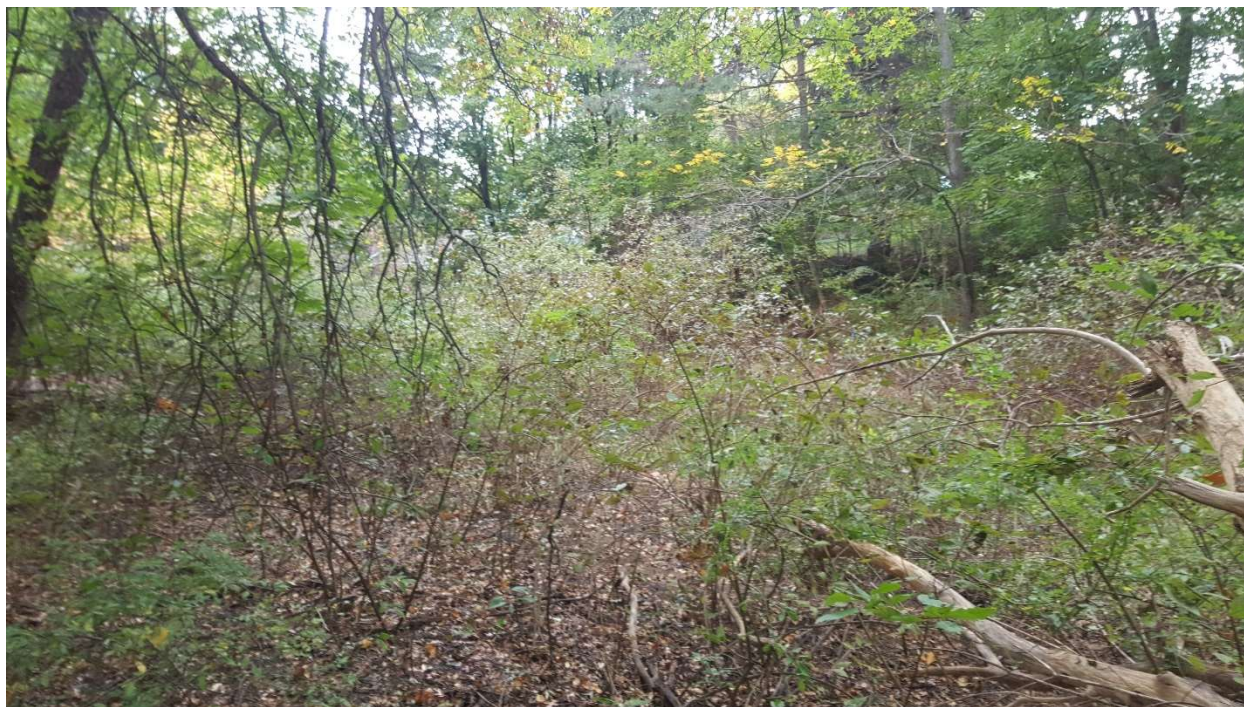
**Figure 32.** BVW east of Buttery Brook (flag series R800-R815). Looking north near flag R804.
